Imaging and Condition Diagnosis of Underground Sewer Liners via Active and Passive Infrared Thermography: a case study in Singapore

Janet F.C. SHAM^{*,a}, Wallace W.L. LAI^a, Wing CHAN^b, Chee Lin KOH^b

Keywords: infrared thermography, defect identification, condition assessment, sewer liners

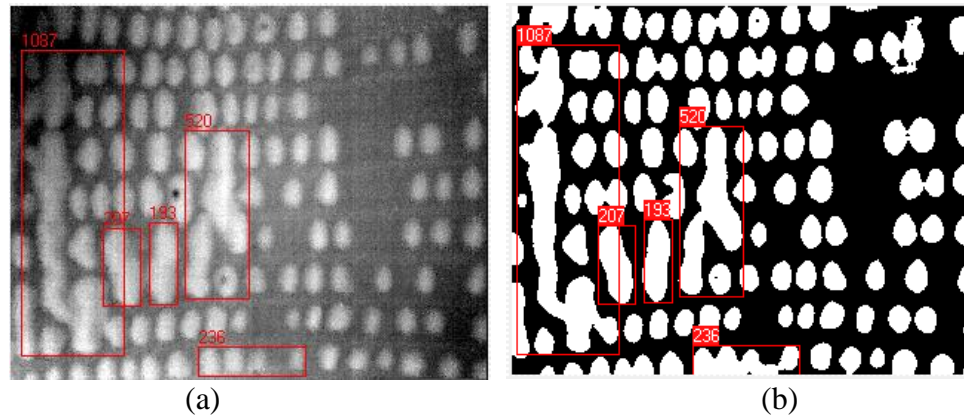
Figure 10: Identification of targeted debond area by IR-SE program (a) raw thermal image and (b) binary image of the corresponding thermal image (a).

The IR-SE program enables automatic detection of targeted debond areas to support maintenance decision-making. Unlike CCTV survey, which is highly subjective based upon individual interpretation, the IR-SE program automatically identifies any debond areas that exceed the thresholds set for the detection criteria. A targeted percentage area of debond relative to the overall image area (i.e. the maximum debond size that may require further attention in future maintenance works) can be set in the program. In the example shown in Figure 10, the debond size threshold was set to an area larger than 1.1% of the entire thermal image. Five debonds were highlighted automatically by the program and are identified on both the raw thermal image and binary image, while other objects (bubble shapes) were considered to be construction details of the AKS HDPE liner as shown in Figure 2. This threshold and its absolute value can be adjusted by the user, thereby giving a clear watershed of judgement (i.e. debond/no debond). The estimated sizes are also shown next to each red rectangle in cm^2 in the binary image (Figure 10) (i.e. sizes of defects from left to right as follows: 1087cm^2 , 207cm^2 , 193cm^2 , 520cm^2 , 236cm^2). Since the curvature of the pipeline

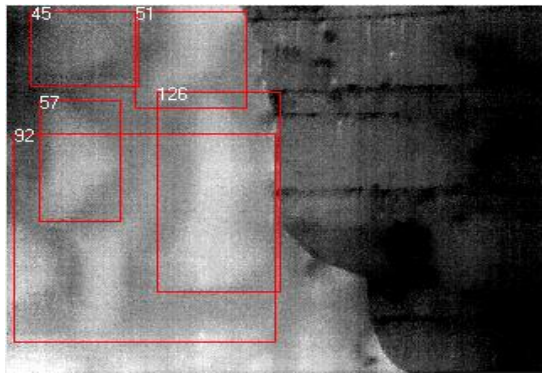
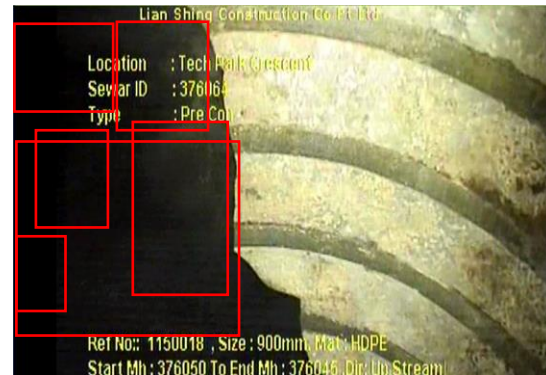
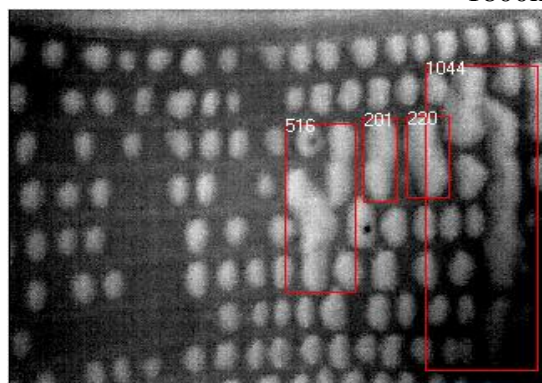
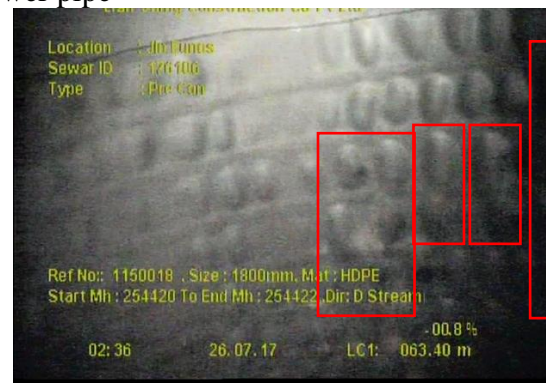
Figure 11: Identification of debond area by IR-SE program (a) raw thermal image and (b) the corresponding CCTV visual image in 900mm sewer pipe; (c) raw thermal image and (d) the corresponding CCTV visual image in 1800mm sewer pipe.

As shown in Figure 11, the debond areas in the 900mm and 1800mm sewer pipes were detected as hot spots (white areas) in the grayscale thermal image. In the 900mm sewer pipe, suspected debond areas are bounded by red rectangles in Figure 11 (a) and (b). These areas can be observed in the thermal image but could not be detected in the CCTV visual image. In the 1800mm sewer pipe, many small white bubbles are observed in Figure 13 (c) and (d). As mentioned before, unlike the 900mm sewer pipe, the 1800mm sewer pipe is a built-in (anchor knob sheet) AKS HDPE sewer pipe. The white bubbles observed in the thermal images are similar to the anchor knob pattern of the AKS HDPE liner in Figure 2. Some of those bubbles are joined together to form bigger debonds, which are bounded by red rectangles in Figure 13 (c) and (d).

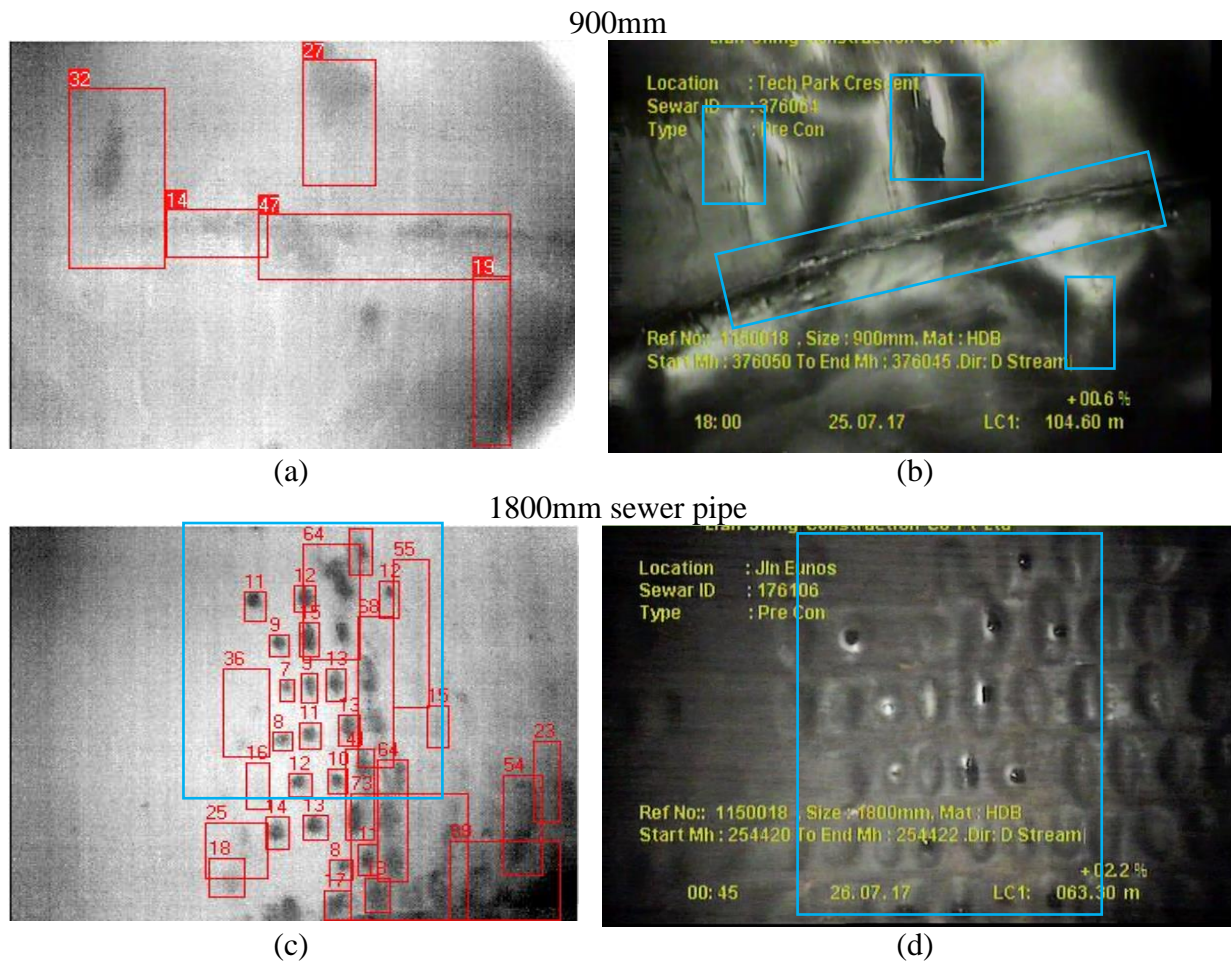
Figure 12: Identification of suspected water seepage area by IR-SE program (a) raw thermal image and the corresponding CCTV visual image (b) in 900mm sewer pipe; (c) raw thermal image and the corresponding CCTV visual image (d) in 1800mm sewer pipe.

As shown in Figure 12, suspected water seepage areas (bounded by a blue rectangle) are picked up in thermal images but it can hardly be identified in the visual image. In the 900mm sewer pipe, suspected water seepage areas are identified at the joints of the sewer pipe in the thermal image in Figure 12 (a), but cannot easily be identified in the visual image in Figure 12 (b). In the 1800mm sewer pipe, signs of water seepage can be observed in both thermal and visual images (Figure 12 (c) and (d)). However, more clear dots indicating water seepage can be observed in the thermal

image (Figure 12 (c)) because our view was not distracted by the liner bubbles and uneven lighting observed in the visual image shown in Figure 12 (d).
