Multi-hazard vulnerability of structures and lifelines due to the 2015 Gorkha earthquake and 2017 central Nepal flash flood

Abstract

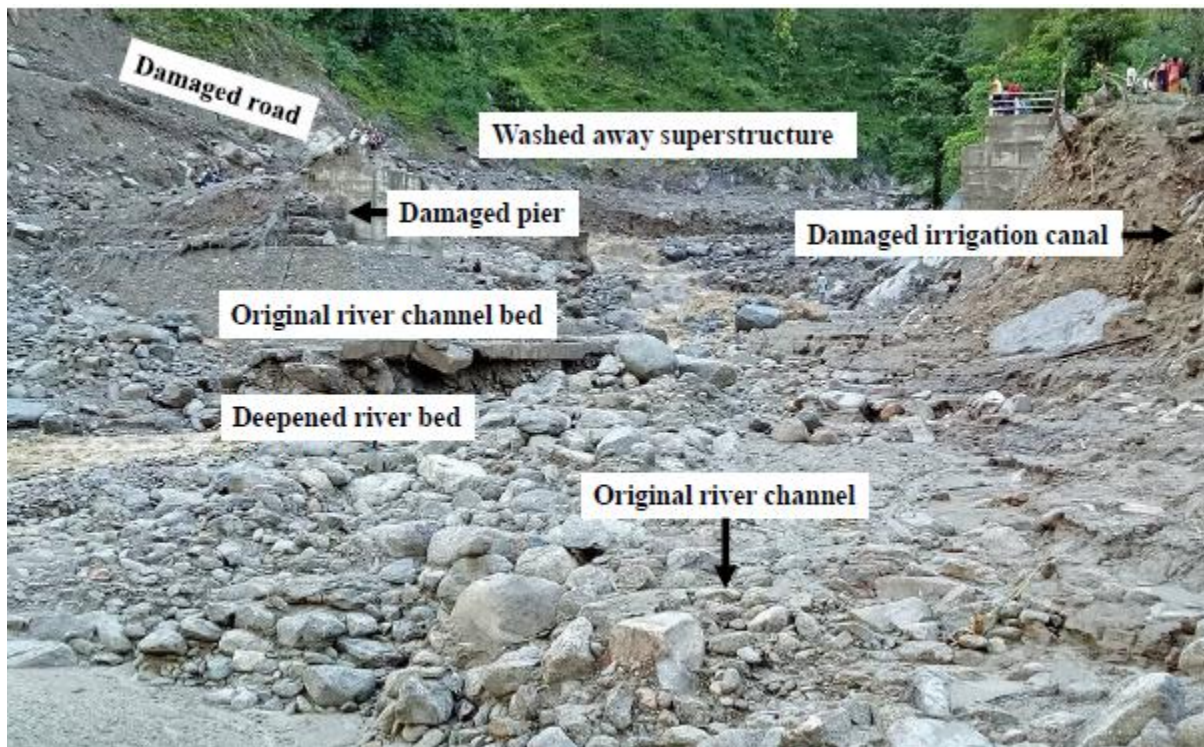
Chhatiune Khola bridge was reinforced concrete single span bridge. The bridge span was 30 m with 10 m height from the previous river bed. Due to the July 2017 flood, the river channel was ~3 m deepened whereas the bridge was destroyed with no indication of parts of the superstructure (Fig. 3).

Fig. 3 Debris flood from the stream due to flash flood in the bridge site

The river channel was shifted ~10 m and the river is currently flowing through previous rice fields. Per the local people, flash floods of such extent were not observed in the last hundred years. Forensic interpretation depicts that there were no concerns of structural deficiencies, however, the hydrodynamic force arising from the turbulent water flow in the steep river channel could have destroyed the superstructure since superstructures are designed providing freeboard per the discharge without due consideration of hydrodynamic forces. In the case of piers, again due to the low discharge scenario, the forces considered during design would not have been

adequate to assure the performance during turbulent flows as in the case of July 2017 flash floods.

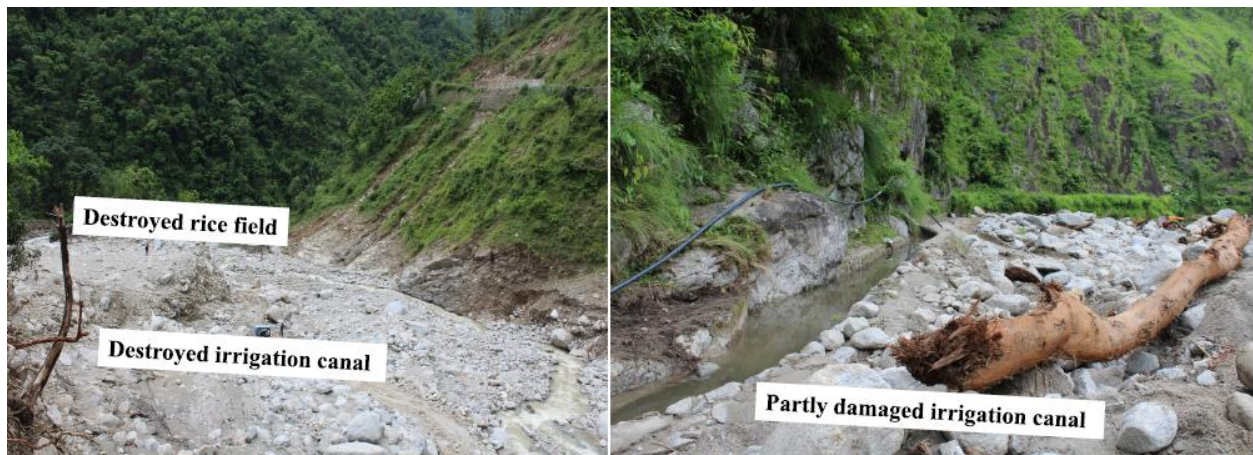
Performance of lifelines during multi-hazards is a seldom discussed topic in Nepal. We observed the damages in irrigation canals, water supply pipeline and electric poles, road network, and roadway sign posts due to the recent flash flood of 2017 which were exposed to Gorkha earthquake too. The damage in lifelines due to the 2015 Gorkha earthquake has been thoroughly reported by the National Planning Commission, Nepal (NPC 2015). To the best of authors' knowledge, limited reports and documents are available for the 2017 flash flood (e.g. Gautam et al. 2017). As shown in Fig. 4, one of the irrigation canal supplying water to nearest rice field was washed away by the flood, meanwhile, local people confirmed that there was no significant damage during Gorkha earthquake.

Fig. 4 Damage to the irrigation canals due to 2017 flash flood

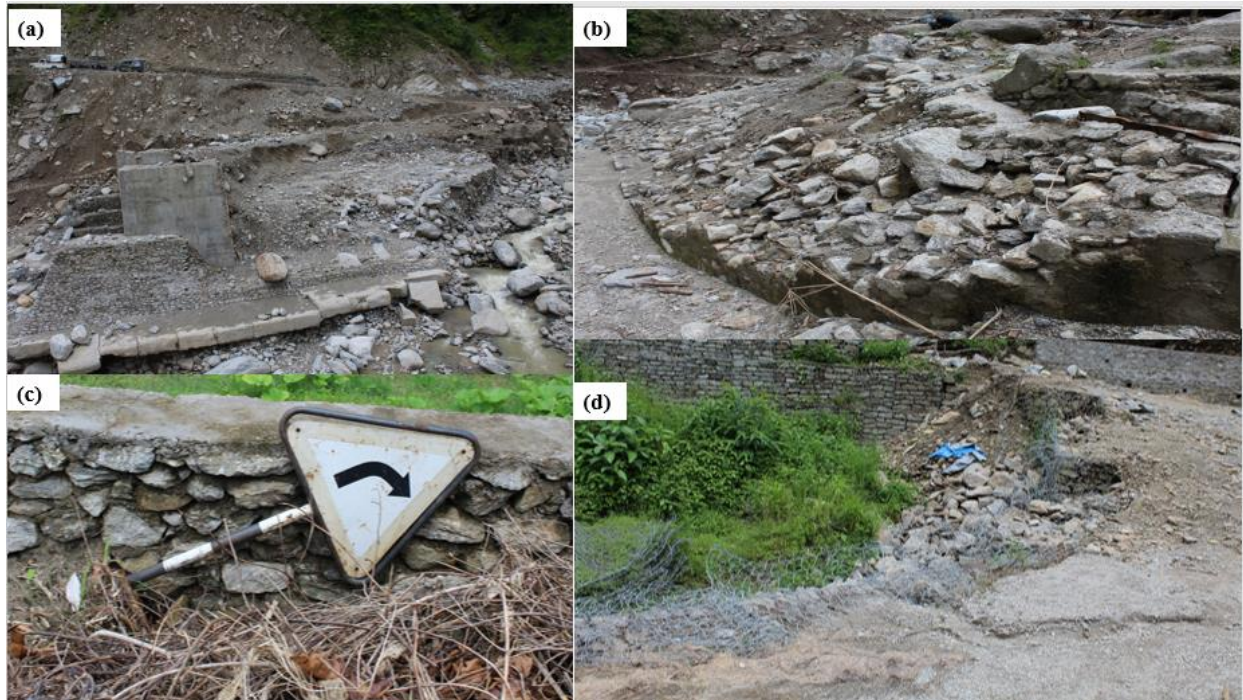
Similarly, ~2 km long feeder road, that connects the neighborhood with the nearest highway, was damaged due to the flash flood as shown in Figs. 5a, 5b. The sign post (Fig. 5c) and slope protection structure (gabion wall) (Fig. 5d) were also damaged due to the flash flood. The damage extent was spread over nearly 200 m territory from the river channel. The feeder road

was single lane unmetalled track along the river bank and no indication of the road was visible during the field visit. In the case of gabion wall, the damage occurred nearly 300 m from the river course.

Fig. 5 a) Road damage due to flash flood; ~2 km long stretch was washed away with no indication of road alignment; b) exposed subgrade of the road; c) damaged sign post along the road; and d) damage to the gabion wall

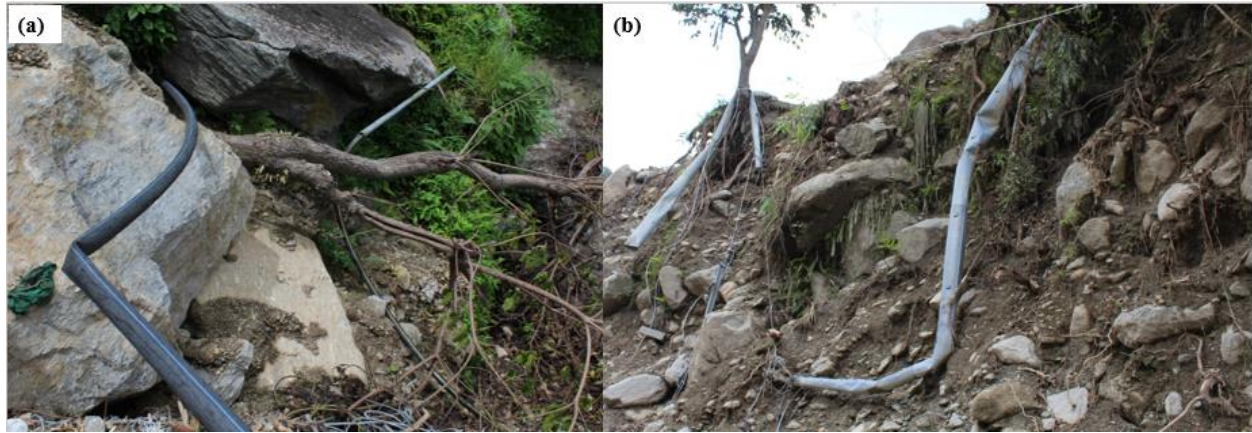
The water supply system was also destroyed by the flash flood as well (Fig. 6a); leading the affected families out of water supply for many days. The water supply pipes were found to be displaced and in many cases destroyed by the cobbles carried by flash floods. The electrical poles throughout the settlement were destroyed due to the flash flood (Fig. 6b). At least five electrical poles were observed to be washed away and the electricity supply was not resumed until the first week of August 2017.

Fig. 6 a) Damage water supply pipeline and b) damaged to the electrical poles

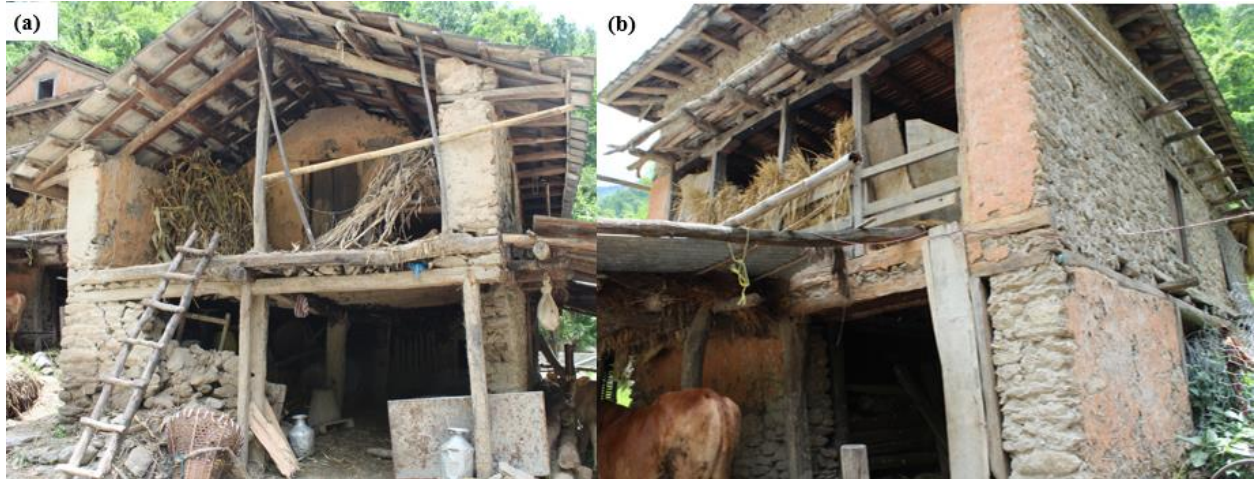
adopted as: minor damage ($\leq 25\%$); major damage (26-50%); severe damage (51-75%); collapse ($>75\%$). All the buildings were continued to use after the earthquake without any repair. The flow height for the destroyed building was estimated to be 3.5 m through the peak flood level measurement at the nearest point. All the four side walls were inundated in the case of the destroyed building thus the building should have been washed away. One of the buildings that sustained severe damage state (Fig. 7a) had dislocated wooden pillars and part of the wall was collapsed. Meanwhile, the building that sustained major damage had cracks on masonry walls (Fig. 7b). The building that sustained minor damage was not exposed to hydrodynamic forces (Fig. 8) thus the minor cracks due to the earthquake were not extended; unlike the building that sustained major damage. The building that sustained severe damage was exposed to the flow height of 3 m whereas the building that sustained major damage was exposed to the flow height of 1.5 m. The sum of observations concluded that hydrodynamic force was the major factor in damage aggravation and the extent of damage depended on the exposure percentage. In the case of collapse, severe damage, and major damage, the hydrodynamic forces along with boulders and cobbles may have played the vital role in damage aggravation if not collapse of the building. The collapsed structure was in the immediate vicinity of the flow thus the water current should have washed away the building.

Fig. 7 a) severe damage and b) major damage to vernacular buildings

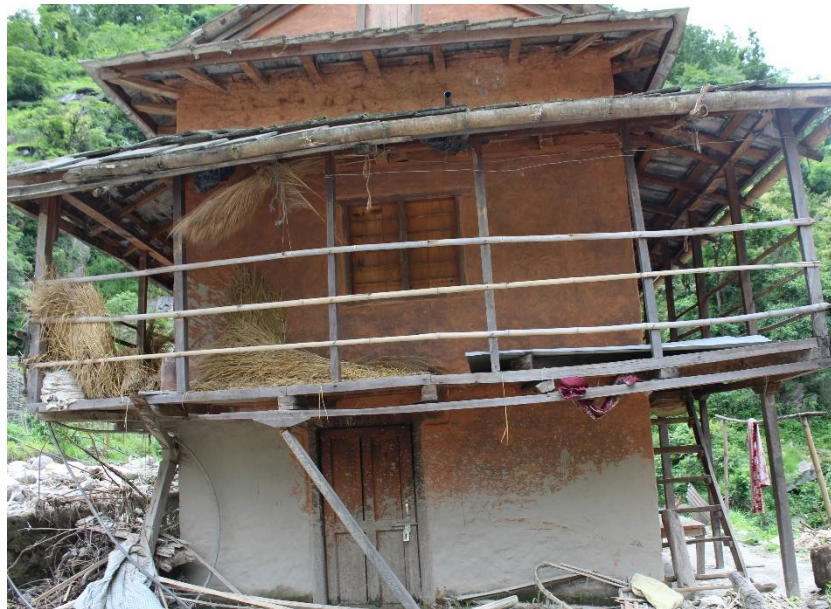
Fig. 8 The flood unaffected but earthquake damaged (minor) vernacular building

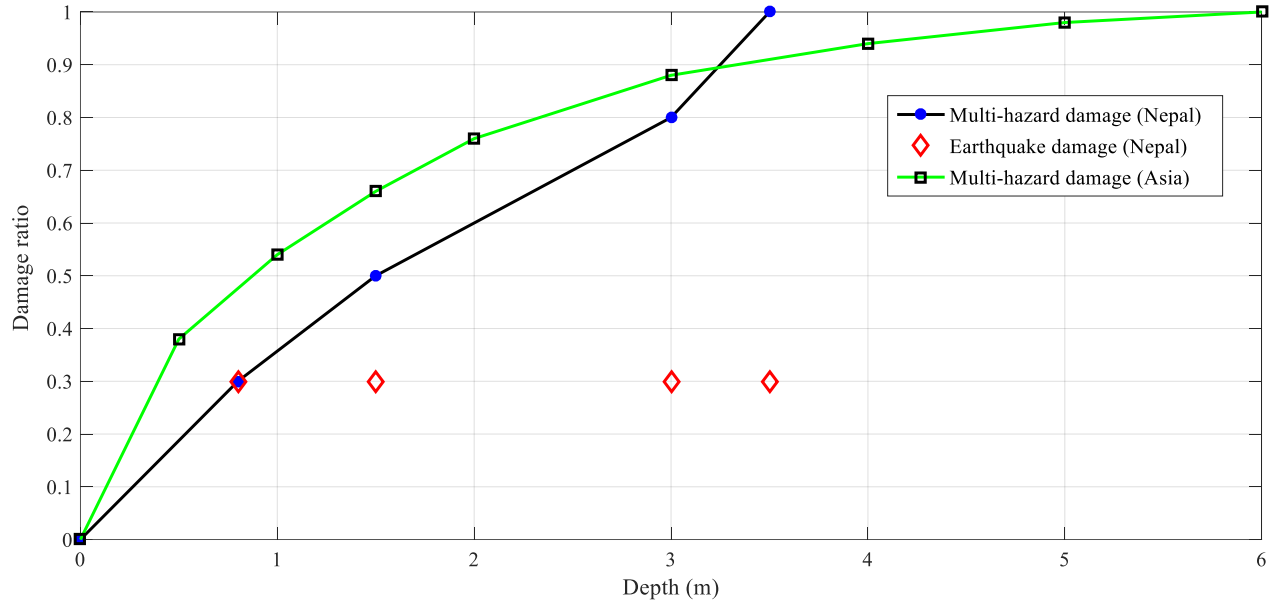
damage curves for vernacular buildings are particularly important in Nepal as most of the river settlements in the river banks have the vernacular mud-mortar stone masonry buildings and no flood and seismic countermeasures are provided. Moreover, consideration of multi-hazards is relatively new for Nepal, thus the changing context would be highlighting the need of depth-damage curves especially for the settlements near rivers and streams. A new approach of multi-hazards vulnerability depiction is presented in this study. This approach incorporates a plot showing both earthquake and flash flood vulnerability in the same depth-damage curve and one can easily distinguish the damage level and aggravation scenario due to individual event (Fig. 9). The percentage of damage as observed in the field are plotted along with the flow height in Fig. 8 to obtain the empirical depth-damage curve. Meanwhile, the depth-damage curve for vernacular Nepali residential buildings is compared with the existing depth damage curve proposed by [Huizinga et al. \(2017\)](#). As all buildings were sustaining minor damage state during the earthquake, exposure to flash flood led damage aggravation to each building that was exposed to flash flood. For instance, the building with minor damage state ($\leq 25\%$ damage) during earthquake was not exposed to the flood directly thus no further damage was occurred whereas the collapsed building was exposed to the hydrodynamic forces to all four facades during the flood event; hence got washed away. The flood damage was increased by 300% in the case of full inundation as observed during the field reconnaissance. The damage increment is calculated based on the existing damage level in all buildings (25%). For instance, if the building was now determined to have major damage level (50% damage), then the increment was obtained to be 100%. In the case of majority of inundation (3 m), the building damage was increased by 200% due to flash flood and in the case of half inundation, the damage was increased by 100% due to the flash flood in earthquake damaged building.

Fig. 9 Depth damage curve and earthquake damage scenario for vernacular buildings in Nepal

As shown in Fig. 9, the depth-damage curve due to the flash flood in Nepal shows the damage in terms of residential buildings is slightly lower than the depth-damage curve for Asia (Huizinga et al. 2017). For example, at a depth of 1 m, 35% damage is expected in residential buildings,

whereas in the case of the depth-damage curve for Asia, the damage is nearly 55%. It should be noted that the depth-damage curve depicted in this study is the one that incorporates multi-hazards damage scenario thus the actual damage in terms of a single event may be lower than 35%. Similarly, in the case of a higher depth, Nepali vernacular residential buildings sustain severer damage than the Asian depth-damage curve suggested by [Huizinga et al. \(2017\)](#). For example, Nepali residential buildings are expected to collapse at a depth of 3.5 m, whereas the depth-damage curve for Asia shows that the damage extent would be 90% only for the same inundation depth. Similarly, at a depth of around 3.2 m, the curves are intersected leading to similar damage state in the case of Nepal and Asia. It is worthy to note that unlike Europe and North America, local construction practices are greatly varied and such variation can be even grave within a country so exact comparison needs similar building types. Meanwhile, the confinement of collapse at the lower depth than the Asian collapse scenario should be attributed to the poor construction practice in Nepal wherein buildings usually do not consist lateral load resisting members and both the seismic and hydrodynamic forces may cause severe damage.
