1  
2 **Microstructural Material Characterization of**  
3 **Hypervelocity-impact-induced Pitting Damage**

17  
18 **Submitted to *International Journal of Mechanical Sciences***

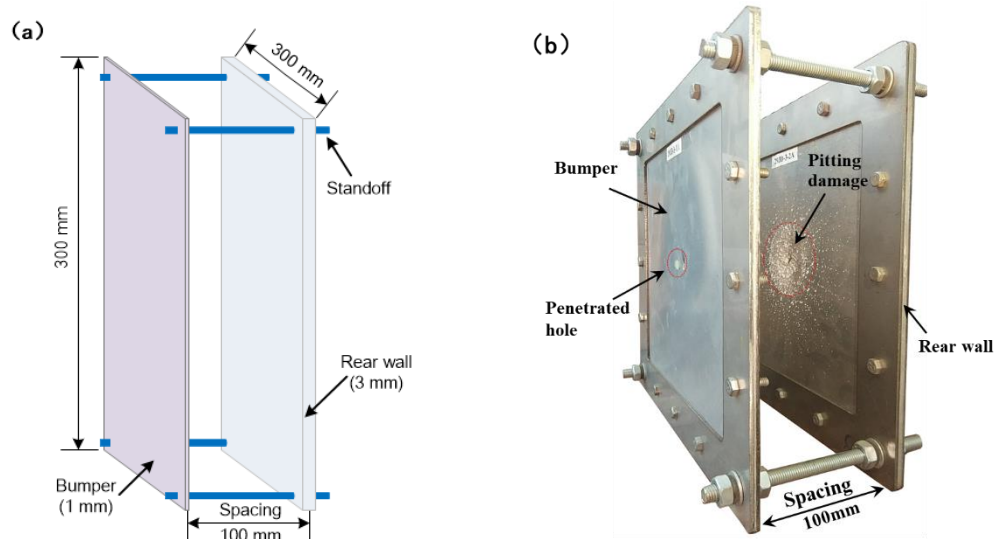
145 **Fig. 1. (a) Schematic of the dual-layered Whipple shield fabricated for HVI test; and (b) photograph of the**  
 146 **Whipple shield after HVI test.**

158 clustered, localized craters and cracks that are scattered disorderedly over a wide area, as  
159 observed in Fig. 1(b).

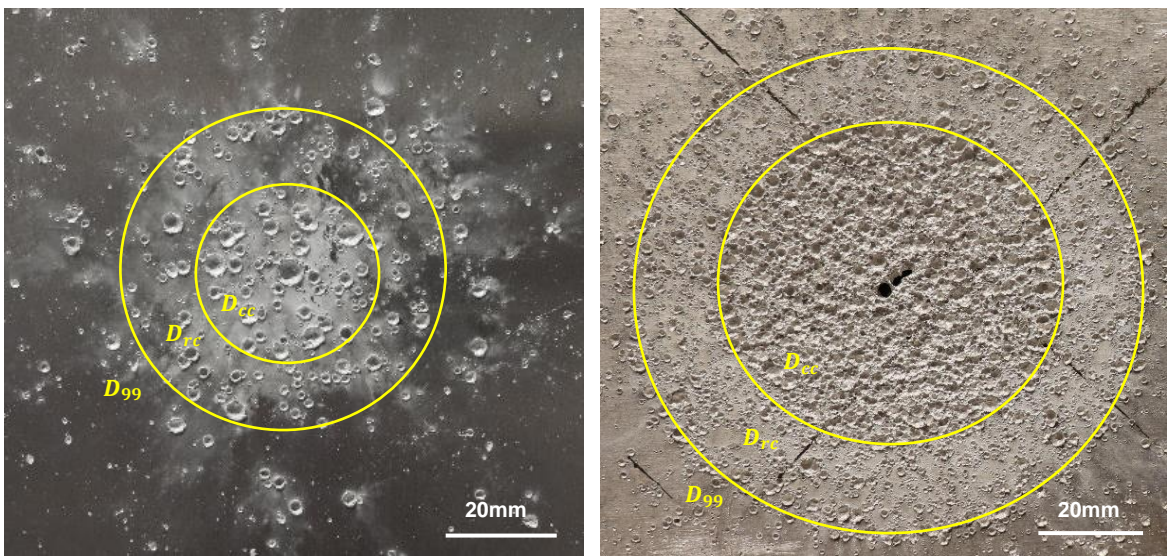
214 Representatively, Fig. 5 shows the debris cloud-induced pitting damage in rear wall layer. The  
 215 sizes, severity degrees and patterns (multitudinous clustered, localized craters and cracks) of  
 216  $D_{cc}$ ,  $D_{rc}$  and  $D_{99}$  clearly underline the effect of structural characteristics of debris cloud  
 217 on generated damage. The diameters of these pitting damage areas are measured from the

218 images of the rear wall. It is apparent in Fig. 5 that the morphology of debris cloud-induced  
 219 pitting craters in  $D_{cc}$ ,  $D_{rc}$  and  $D_{99}$  are irregular when compared against the hemispherical  
 220 morphology of craters induced by a single projectile normal impact. To investigate this, three-  
 221 dimensional (3D) morphological characterization of the pitting damage is conducted with the  
 222 LSM featuring a spatial resolution of 10  $\mu\text{m}$ . The diameters and depths of the craters are  
 223 measured from the cross-sectional profiles of these 3D models (Fig. 6), to quantify the severity  
 224 of these pitting craters. Two key observations from the 3D characterization are:

226 **Fig. 5.** Morphology of debris cloud-induced pitting damage in rear wall: (a) projectile speed: 4.13 km/s,  
 227 diameter:3.2 mm (left); and (b) projectile speed: 5.93 km/s, diameter:4.5 mm (right).

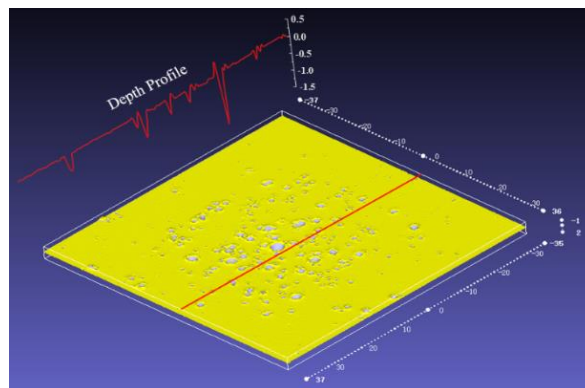
230 **Fig. 6.** 3D morphology of the pitting damage (projectile speed: 4.13 km/s, diameter:3.2 mm).

241 impact spot of rear wall further melts under high shock wave stress and dramatic  
 242 elevation of temperature. In  $D_{cc}$ , visible macro-scale cracks are observed around the  
 243 craters, along with deformation at the backside of the rear wall, implying a severe plastic  
 244 deformation of the material in  $D_{cc}$  during HVI from the debris cloud;

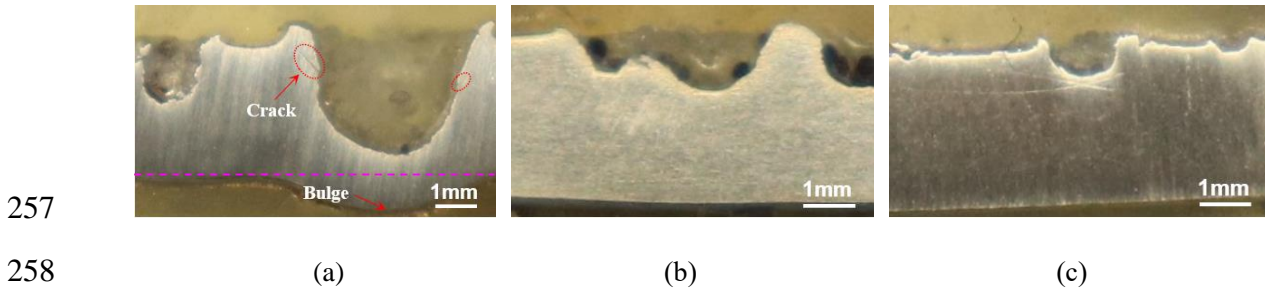
259 **Fig. 7.** Profile images of representative pitting craters in (a)  $D_{cc}$ ; (b)  $D_{rc}$ ; and (c)  $D_{99}$  (projectile speed:  
260 4.13 km/s).

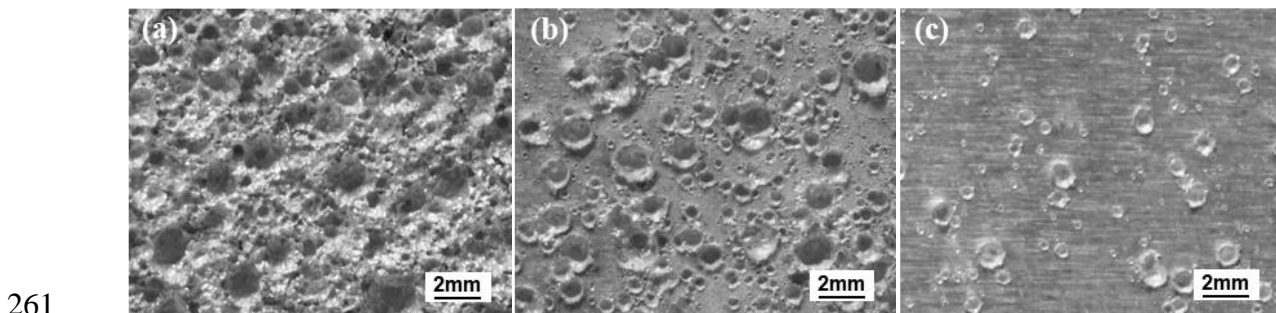
245 (2) when the initial speed of the projectile increases to 5.93 km/s, massive tiny particles  
 246 ranging from tens to hundreds of microns (even millimeters) are generated, resulting in  
 247 a reduced number of primary craters whereas more sub-craters and micro-craters. At such  
 248 a high impact velocity, the materials of projectile and bumper change to molten liquid  
 249 droplets or vapor, and the damage degree, in terms of crater depths, is consequently  
 250 mitigated, Fig. 5(right). To take a step further, the surface morphology of  $D_{cc}$ ,  $D_{rc}$  and  
 251  $D_{99}$  is compared in Fig. 8, to observe that the surface of  $D_{cc}$  features a large number of  
 252 pitting craters that are mutually nested and overlap another, Fig. 8(a) – caused by multiple  
 253 collisions of debris particles and high temperature droplets. In  $D_{rc}$ , isolated sub-craters  
 254 and numerous micro-craters are clearly observed, in Fig. 8(b), which are introduced to

255 the rear wall by tiny debris particles, forming a rough and uneven pitting crater surface.

256 In  $D_{99}$ , small and shallow pitting craters with rough surfaces are noted, Fig. 8(c).

262 **Fig. 8.** Surface morphologies of (a)  $D_{cc}$ ; (b)  $D_{rc}$ ; and (c)  $D_{99}$  (projectile speed: 5.93 km/s).

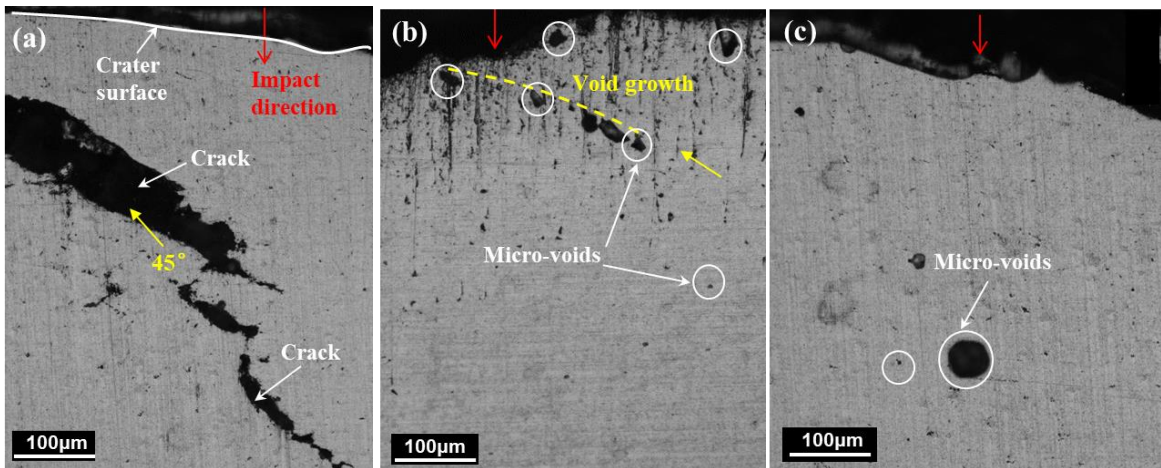
276 In the pitting damage area, in addition to those visible macroscopic craters and cracks,  
277 microstructural defect also manifests itself in diverse modalities, as observed in optical  
278 micrograph images. For illustration, Fig. 9 displays the microstructures beneath  $D_{cc}$ ,  $D_{rc}$   
279 and  $D_{99}$ , revealing numerous micro-voids and micro-cracks in the vicinity of pitting craters.  
280 It is the high pressure of HVI-induced shock waves (tens of GPa) – two orders of the  
281 magnitude higher than that of the strength of 5A06 alloy ( $\sim 0.314$  GPa) – that leads to the  
282 formation of cracks beneath the pitting crater, and this observation indicates that the material  
283 adjacent to the crater bottom undergoes severe plastic deformation during the debris cloud  
284 impact (Fig. 9(a)). The numerous micro-voids are a potential precursor to initiate macroscopic  
285 cracks (Fig. 9(b)), leading to material failure; and the micro-cracks nucleate and expand in a

286 direction approximately  $45^\circ$  to the impact direction (Figs. 9(a) and (b)).

287  
288 **Fig. 9.** Microstructural images beneath (a)  $D_{cc}$ ; (b)  $D_{rc}$ ; and (c)  $D_{99}$  (projectile speed: 4.13 km/s).

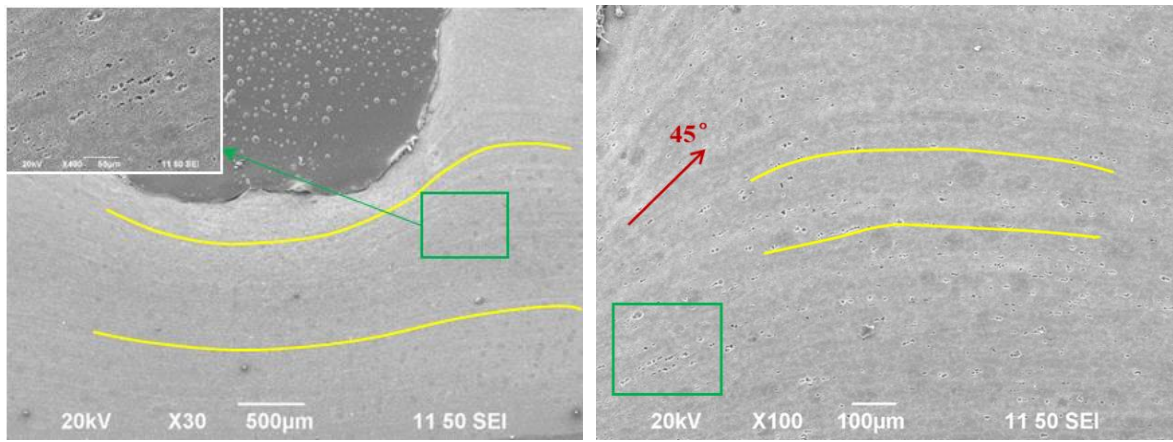
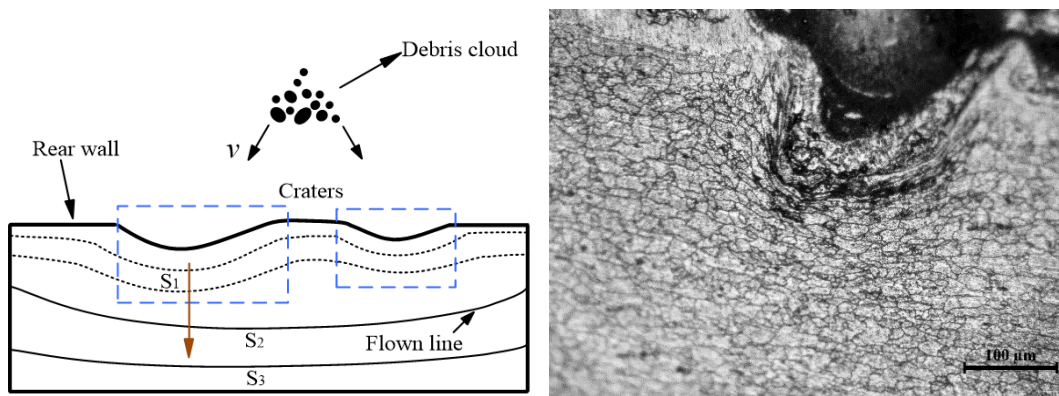
289  
290 The micrographs showing the microstructure of the material in  $D_{cc}$  are presented in Figs.  
291 10(a) and (b), in which compressive-type damage regions of concavity shapes are observed  
292 adjacent to the craters bottom, along with numerous micro-voids distributed along the flown  
293 lines. The concavity shape of these flown lines argues that the wavefront of HVI-induced

294 shock waves normal to the target panel are spherical or quasi-spherical. High pressure and  
 295 high temperature near the impact site make the material behave like an ideal incompressible  
 296 fluid or viscous fluid, while such a fluid-like property of the material is weakened dramatically  
 297 away from the crater bottom, because the plastic strain attenuates remarkably, leading to the  
 298 change in the shape of the flown lines from concavity to near flat planes (see Fig. 10(c)).  
 299 Simultaneously, a series of parallel fluid layers with different flowing velocities are created,  
 300 resulting in the generation of whirlpool-like bands beneath the pitting craters, as observed in  
 301 Fig. 10(d).

306 **Fig. 10.** (a) Microstructure of material under craters in  $D_{cc}$ ; (b) microstructure of material between two  
 307 craters in  $D_{cc}$ ; (c) schematic description of debris cloud-induced shock wave propagation; and (d) optical  
 308 image of the whirlpool-like bands (projectile speed: 4.13 km/s).

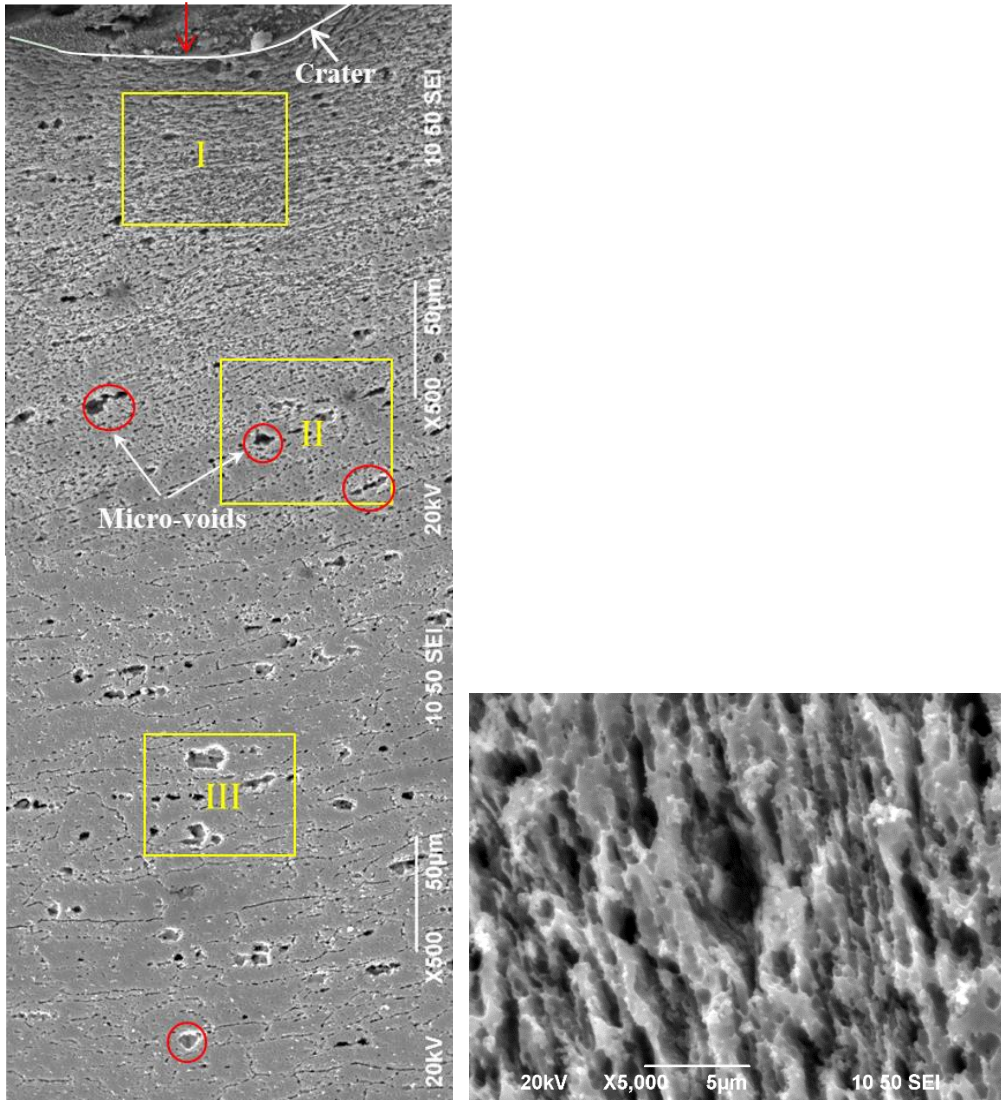
310 The SEM image of material in  $D_{cc}$  is shown in Fig. 11, unveiling that distinct fine grains are  
311 generated in the microstructure of material beneath the crater bottom, and the average grain  
312 sizes are  $\sim 2 \mu\text{m}$  in region I (nearest to the pitting crater bottom),  $\sim 10 \mu\text{m}$  in region II,  
313 and  $\sim 20 \mu\text{m}$  in region III (furthest to the pitting crater bottom), as marked in Fig. 11(a),  
314 compared with the average size of the original grains of  $\sim 40 \mu\text{m}$  (Fig. 2) prior to HVI. The  
315 smaller the grain size the more severe the degree of compression to the material will be; the  
316 further the distance from the pitting crater bottom, the less compressive plastic deformation of  
317 the material it is, as seen in Fig. 11(a). This observation suggests that non-uniform plastic  
318 deformation and localized recrystallization occur along the impact direction (see red arrow in

324 Also observed in Fig. 11(a) are multitudinous micro-voids at the grain boundaries and within  
325 the grains. The number and size of micro-voids in the coarse grain regions II and III are  
326 observed larger than those in the fine grain region I, because material in region I undergoes  
327 the strongest effect from the shock wave, resulting in micro-voids shrinking and even  
328 disappearance; the shock waves are reflected from the back surface of the rear wall to form a  
329 rarefaction wave (tensile-type), giving rise to expansion of micro-voids in region III and II.  
330 The sizes of micro-voids at the grain boundaries are generally smaller than those within the  
331 grains, due to the effect of concentrated stress and higher distortion energy at the grain  
332 boundaries.

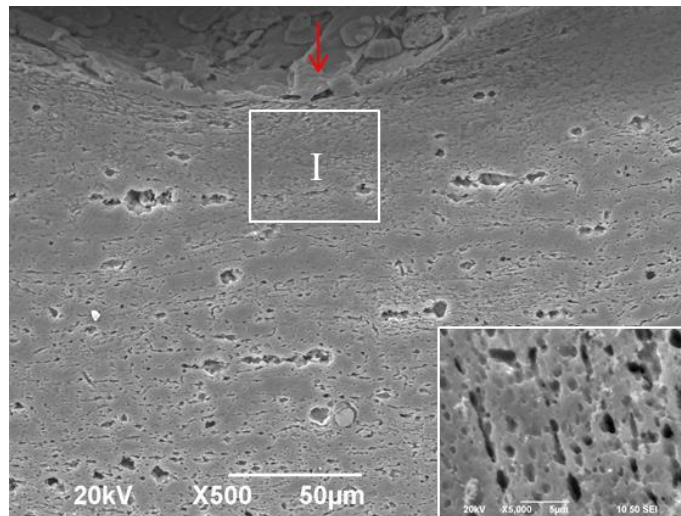
340 Compared with the microstructure of material in  $D_{cc}$  (Fig. 11(a)), that in  $D_{rc}$  (Fig. 12) is

351 **Fig. 12.** SEM image of material beneath the crater in pitting damage area in  $D_{rc}$  (projectile speed: 4.13  
352 km/s).

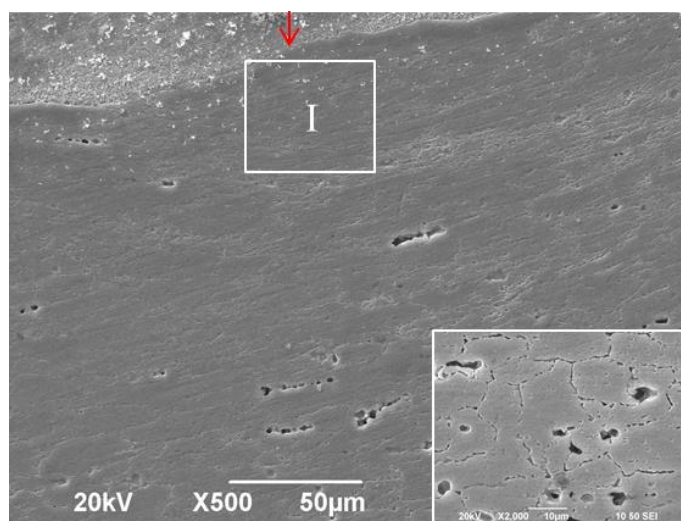
355 **Fig. 13.** SEM image of material beneath the crater in pitting damage area in  $D_{99}$  (projectile speed: 4.13  
356 km/s).

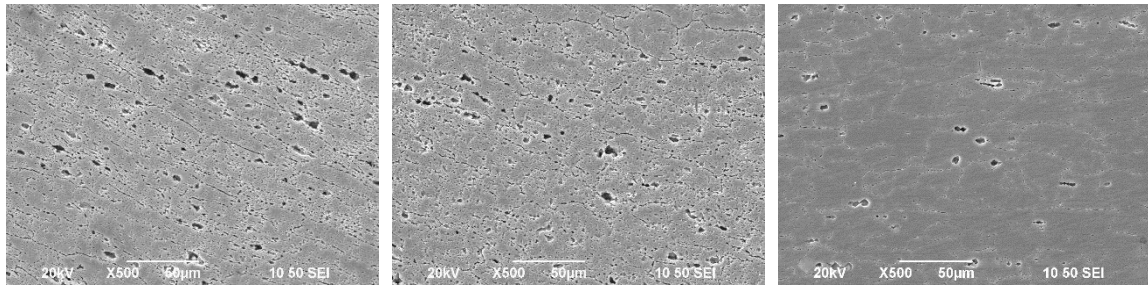
358 It is also relevant to note that both the number of micro-voids and their volume fraction, in  
359 coarse grain regions (*i.e.*, regions II and III, 200  $\mu\text{m}$  away from the crater bottom) in  $D_{cc}$ ,  
360  $D_{rc}$  and  $D_{99}$ , are all increased dramatically as the plastic deformation intensifies, indicating  
361 the accumulation of micro-damage during debris cloud-induced HVI, as seen in Fig. 14.

(a) (b) (c)  
**Fig. 14.** SEM images of materials in different pitting damage areas, 200 $\mu\text{m}$  away from the crater bottom:  
(a)  $D_{cc}$ ; (b)  $D_{rc}$ ; and (c)  $D_{99}$  (projectile speed: 4.13 km/s).

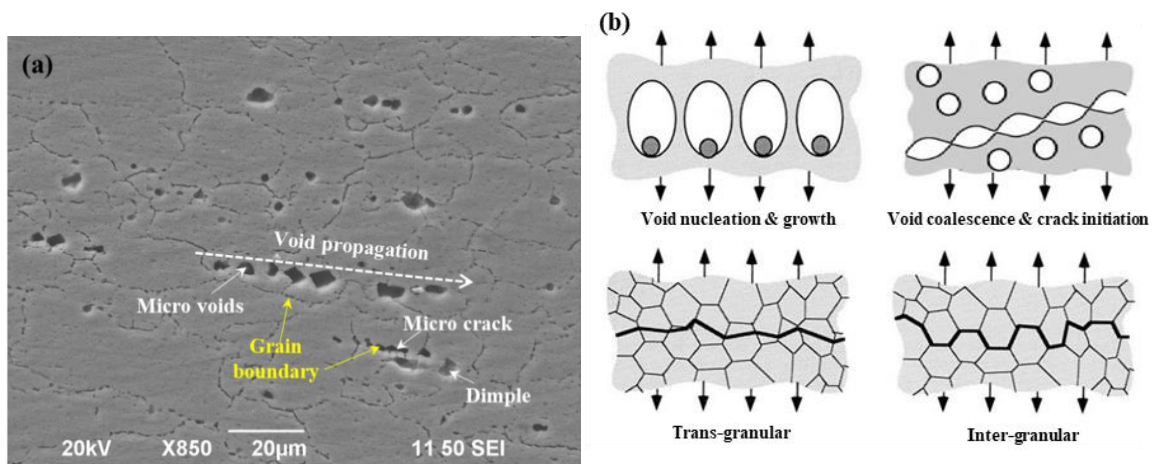
386  
 387 **Fig. 15.** (a) SEM image of material in  $D_{cc}$ , showing void nucleation and propagation; and (b) schematic  
 388 of void nucleation, growth and coalescence [26-28].  
 389

390 As observed in Fig. 15(a), all micro-voids feature near spherical shapes with smooth surfaces,  
 391 and that is because under the elevated temperature during HVI, the material within the micro-  
 392 voids melts. It is surmised that under an extremely high shock stress, more dislocation cells  
 393 exist in the material, introducing stress concentration at grain boundaries and further grain  
 394 boundary slip. As a result, the initiation of micro-voids and formation of recrystallization  
 395 nucleus take place at grain boundaries first. The coalescence of grain boundaries further gives  
 396 rise to the micro-void shrinking or disappearance. Consequently, fewer micro-voids with  
 397 smaller sizes (micron in diameter) can be observed at grain boundaries, in Fig. 15(a).

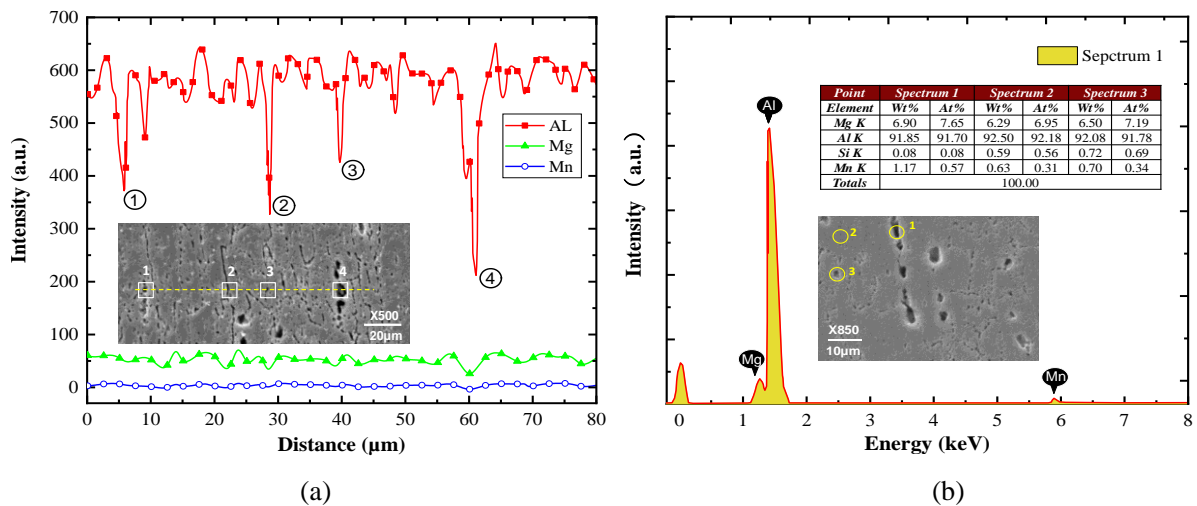
423 Spot analysis and line scanning tests are conducted using EDS on the material extracted from  
 424 the rear wall, to identify and determine quantitatively the chemical compositions of the  
 425 material in the pitting damage area. The EDS line scanning result, Fig. 16(a), shows that the  
 426 concentration of the element AL decreases significantly at voids (①, ③ and ④) and also at the  
 427 crack along grain boundary (②), which once again corroborates earlier statement that the  
 428 debris cloud-induced the pitting damage features voids and cracks. EDS spectrum analysis  
 429 result, Fig. 16(b), illuminates the proportion of material compounds at three different testing  
 430 points where a void exists or not. The results highlight that the compound compositions of  
 431 materials at all testing points are similar, and only the proportion of element is slightly different.

434 **Fig. 16.** (a) EDS line scanning analysis result; and (b) EDS spectrum (wt%: weight percentage, At.%:  
 435 atomic percentage) (projectile speed: 4.13 km/s).

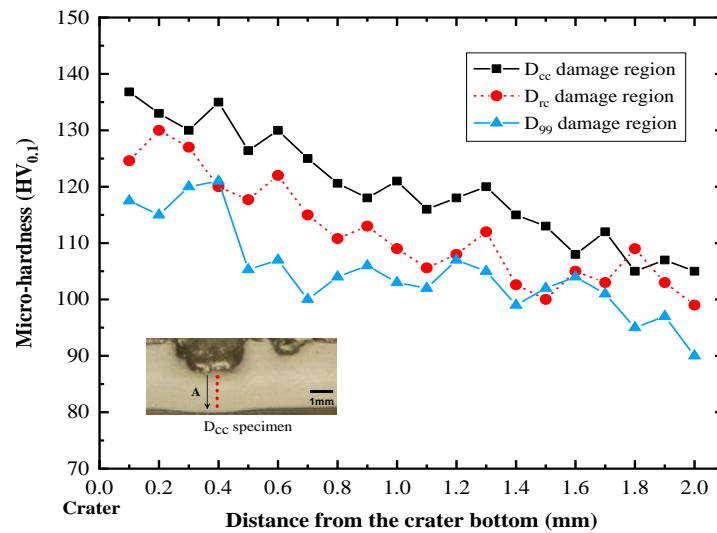
438 Micro-hardness of the rear wall layer containing pitting damage is calibrated at a series of  
 439 testing points along the wall thickness with the first point being 0.1 mm below the pitting  
 440 crater bottom. Fig. 17 shows the obtained micro-hardness distribution, to observe that the  
 441 extents of micro-hardness of  $D_{cc}$ ,  $D_{rc}$  and  $D_{99}$  are higher than that of the base metal

442 (HV85) of the rear wall, which can be attributed to the intensification of the strain and strain-  
 443 rate hardening effects due to HVI. The micro-hardness drops away from the pitting crater  
 444 bottom. The SEM images, Fig. 11, show that the grain structures beneath the craters are  
 445 flattened, namely *shock hardened* – meaning higher micro-hardness. That is because during  
 446 HVI the local melting and rapid cooling of the material can refine the grains adjacent to the  
 447 pitting crater bottom, accompanying with plastic deformation and augment in material density.  
 448 By way of illustration, the micro-hardness of the material near the pitting crater in  $D_{cc}$  is  
 449 136.8 HV – that is 1.6 times the hardness of the base metal.

451 **Fig. 17.** Micro-hardness distribution of materials in  $D_{cc}$ ,  $D_{rc}$  and  $D_{99}$  (projectile speed: 4.13 km/s).

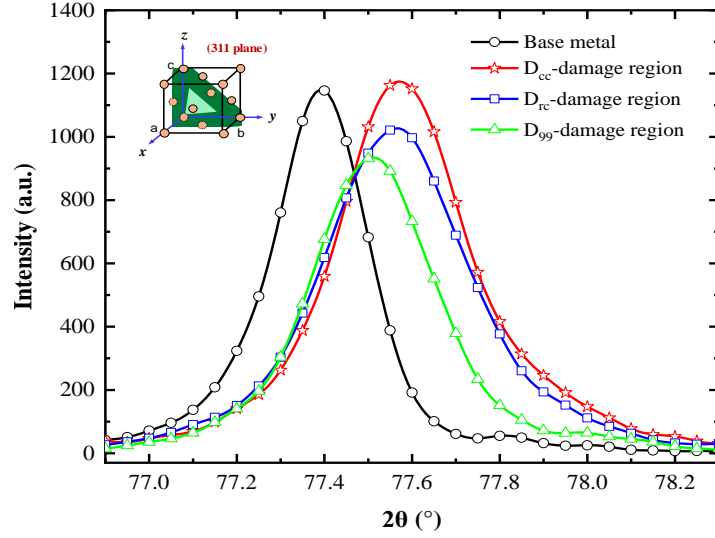
454 To investigate the changes in the dislocation density of material in  $D_{cc}$ ,  $D_{rc}$  and  $D_{99}$ , XRD  
 455 analysis is implemented, and representative (311) diffraction peaks are shown in Fig. 18.  
 456 Compared with that of the base metal of the rear wall, the intensities of diffraction peaks for  
 457 the material in  $D_{cc}$ ,  $D_{rc}$  and  $D_{99}$  are observed largely unchanged, while the peak angle  
 458 shifts upward and the peak width increases significantly. This upward shift of the peak angle  
 459 represents a decrease in the (311) plane spacing in the compression direction of the plate; while

460 the increase in the diffraction peak width implies that the dislocation density augments, as a  
 461 result of plastic deformation in the material.

462  
 463 **Fig. 18.** Representative (311) diffraction peaks for materials in base metal,  $D_{cc}$ ,  $D_{rc}$  and  $D_{99}$  (projectile  
 464 speed: 4.13 km/s).

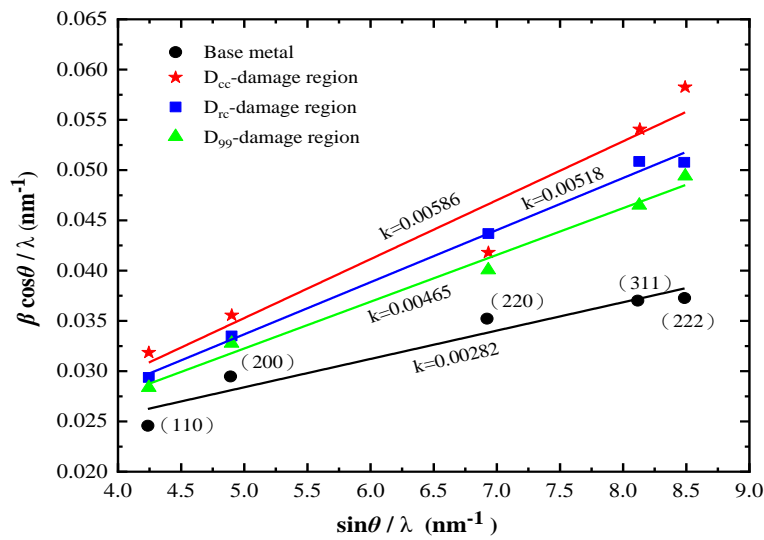
477 where  $\theta$  is the diffraction angle,  $\lambda_w$  the wavelength of the incident X-ray  
 478 ( $\lambda_w = 0.15405$  nm), and  $d$  the average crystallite size. Using Eq. (6), the Williamson-Hall  
 479 plot of materials in  $D_{cc}$ ,  $D_{rc}$  and  $D_{99}$  are obtained and displayed in Fig. 19, revealing that  
 480 materials in different regions have different strains – reflected by distinct slopes of the curves.  
 481 With the increase of  $DCPKE$  in  $D_{cc}$ ,  $D_{rc}$  and  $D_{99}$ , the degree of pitting damage is  
 482 intensified, resulting greater heterogeneous strains.

483  
 484 **Fig. 19.** Williamson-Hall plot of materials in base metal,  $D_{cc}$ ,  $D_{rc}$  and  $D_{99}$  (projectile speed: 4.13  
 485 km/s).
