Seismic vulnerability and inventory of at-risk elements in the wine industry: Auckland region case study

Olabode E. Ogunmakinde^a, Temitope Egbelakin^b, Temitope Omotayo^{c,*}, Adebayo Sojobi^d

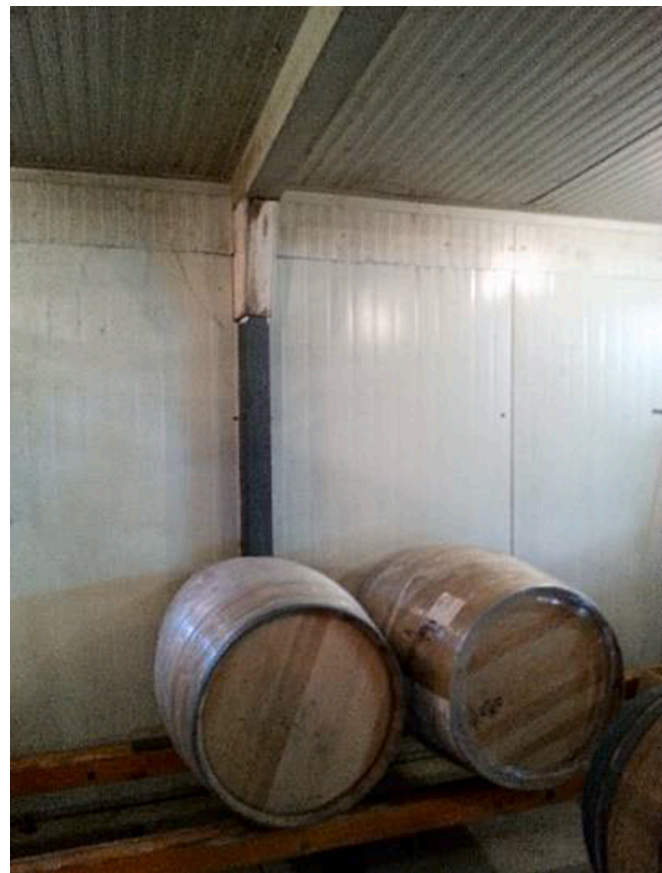
Fig. 4. Winery (w) 02 interior wall.

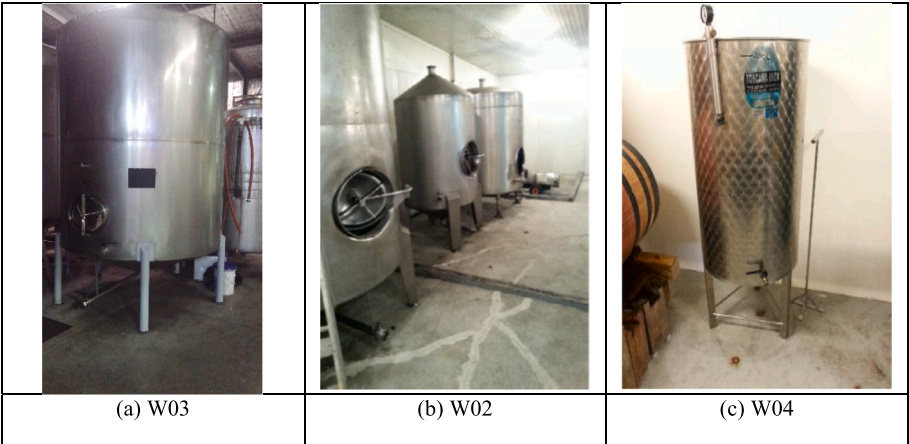
Fig. 5. Slender and small legged tanks used in wineries (W).

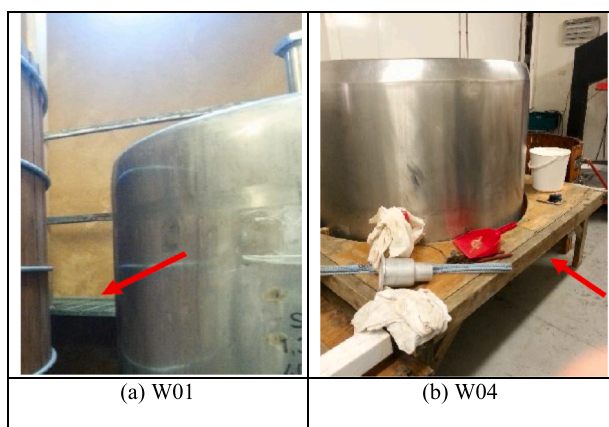
Fig. 13. Catwalks used in wineries.

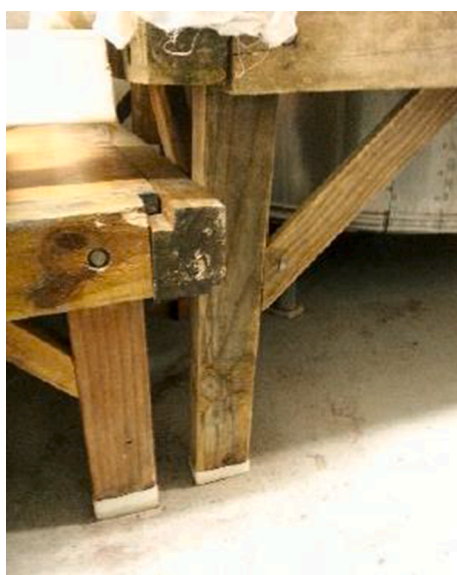
Fig. 14. Legs and top of catwalk used in W04.

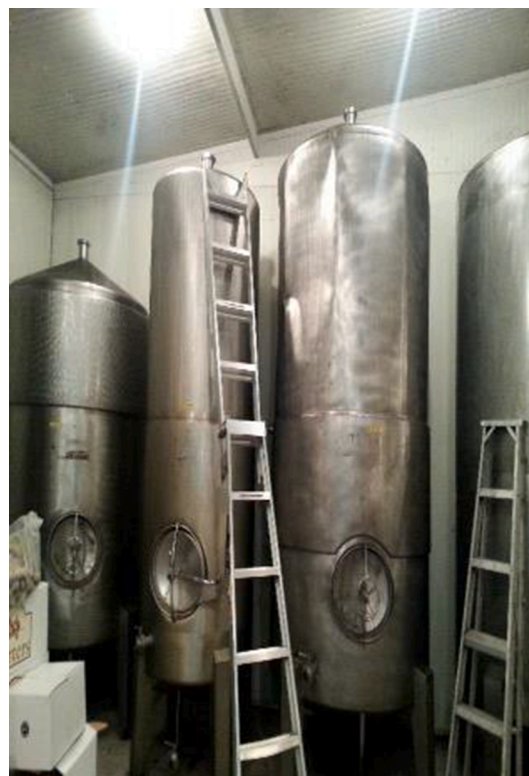
Fig. 15. Ladders used to access top of storage tanks.

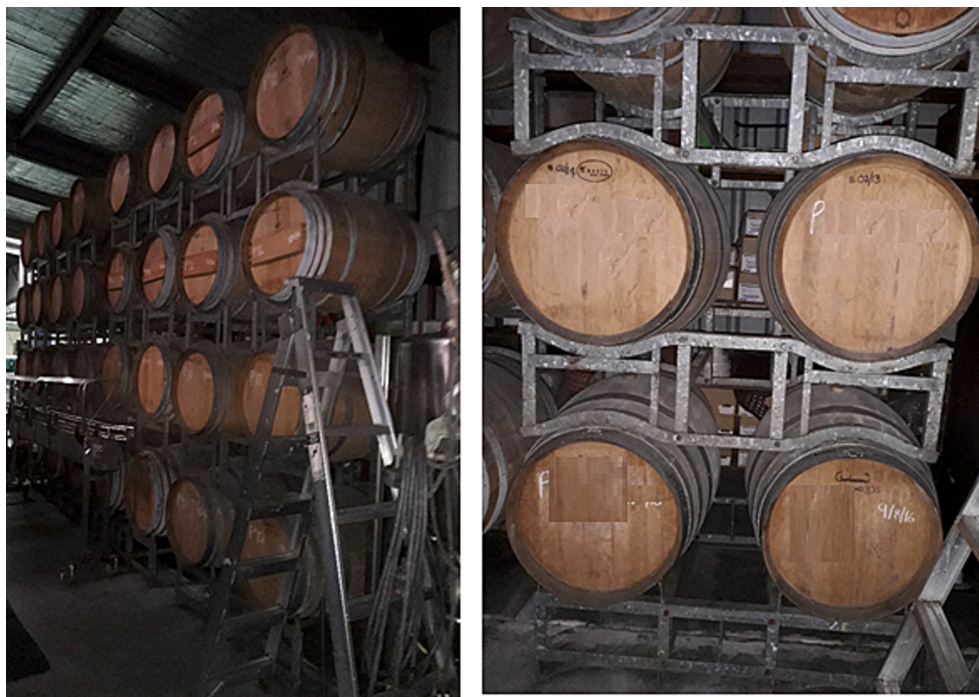
Fig. 17. Racking system used in the winery 03.
