1 **Deterioration Mapping in Subway Infrastructure using Sensory Data of GPR**

3 **ABSTRACT**

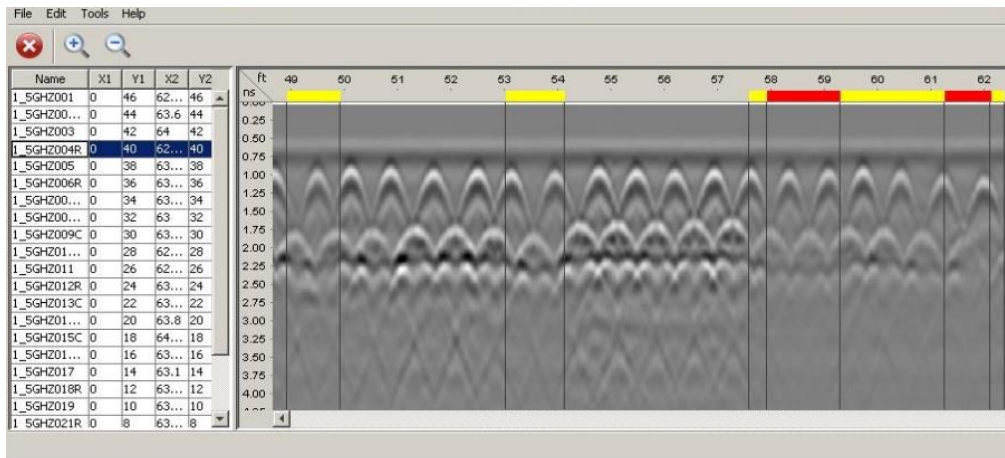
Fig. 1. Marking the deteriorated zones using IBA

157 in yellow and the very severe zones in red as illustrated in Fig. 1. While marking the zones, the
 158 analyst takes into consideration numerous factors, such as surface distresses, variations of rebar
 159 spacing, alignment, and depth, etc. The boundaries of the deteriorated zones marked in each GPR
 160 profile are automatically processed to generate a 2D plan map of the area using a specialized
 161 software.

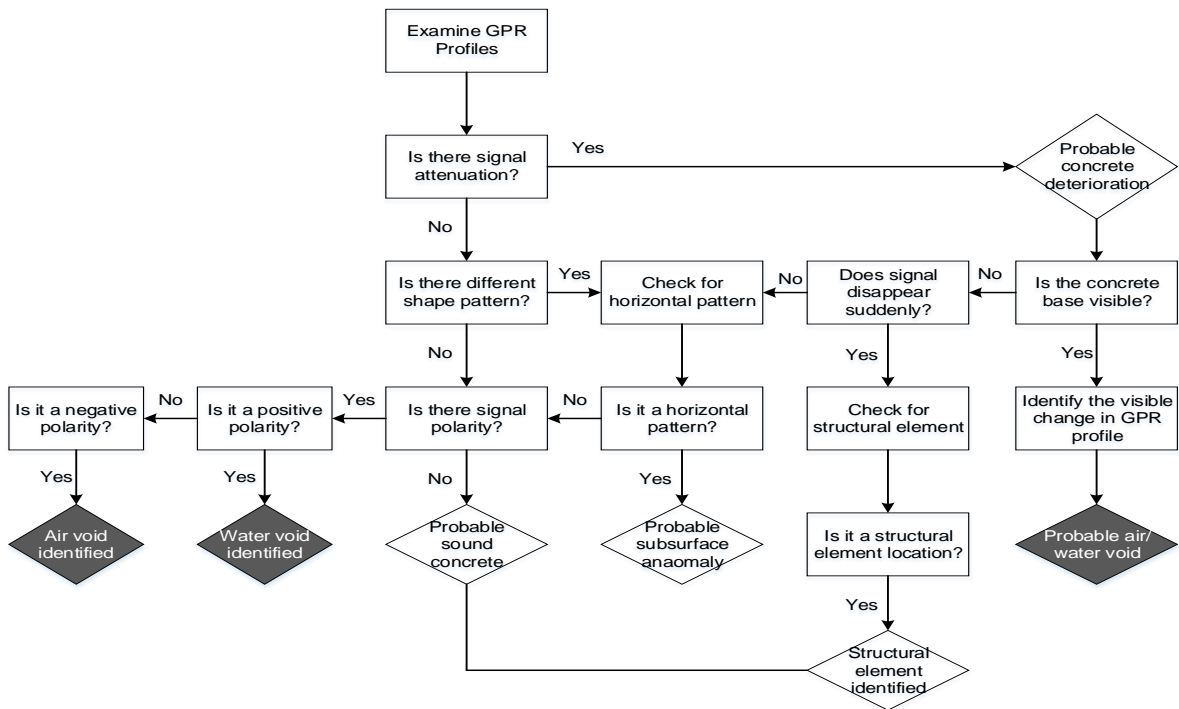
Fig. 4. Framework of air/water voids detection

213 The GPR data processing is conducted using a series of If-Then rules. This procedure is based on
 214 understanding the nature of the inspected structure, as well as, on the factors considered and/or
 215 eliminated for each GPR profile. The following represent the factors to be considered in this
 216 procedure:

- 217 a) Shape Pattern: In the IBA, the analyst scrolls each GPR profile and visually analyzes the
218 signals. Once the analyst finds a distinct shape pattern, a thorough check for the pattern is
219 performed. If it is a horizontal pattern, this indicates any anomaly in the concrete other than
220 air/water void pocket, therefore it should be excluded from the analysis process. If the
221 pattern displays a non-horizontal shape, it may possibly be an air/water void defect.

- 222 b) Wave Amplitude: As the beam of electromagnetic wave is transmitted through different
223 materials, it will encounter an interface between two media of different dielectric constants,
224 hence its amplitude will alter accordingly. The amplitude inversion is due to various causes.
225 It might be an indication of a structural element such as a steel joint, or a deterioration in
226 concrete, i.e., air/water voids, or any concrete distress.

- 227 c) Signal Polarity: Reflection polarity is a function of dielectric constant between two media,
228 therefore, it can gauge and infer the subsurface condition. The dielectric constants of air,
229 water, and concrete are quite distant from each other, as it is equal to 1 for air, 81 for water,
230 and ranges 6-12 for concrete (Gehrig et al. 2004). Negative polarity occurs when the
231 dielectric constant of layer 1 is more than the dielectric constant of layer 2 and vice versa.
232 The signal polarity characteristic can provide tremendous benefits in detecting air/water
233 voids in concrete infrastructure since the air void will display a negative (reversed) polarity,
234 whereas a positive polarity will appear when there is a water void in the vicinity.

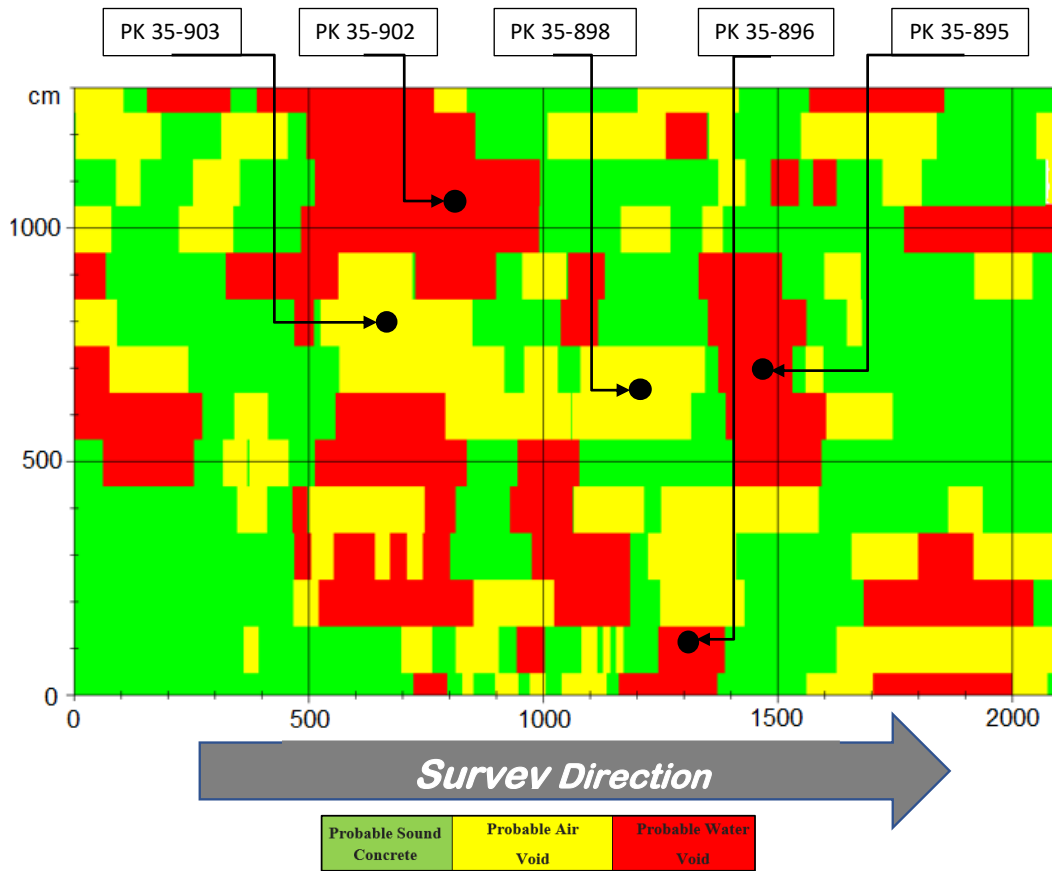
Fig. 8. Deterioration map of the tunnel vault

303 previously marked zones and generated the deterioration map of the tunnel vault automatically as
 304 depicted in Fig. 8.
 305 The figure demonstrates that almost half the vault is found to be sound concrete as it is mapped in
 306 the green zone area, while the other half is located in the yellow and red zones where different
 307 elevations of probable air and water voids are in the vicinity.

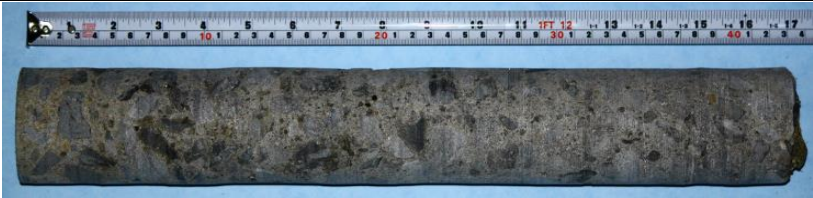
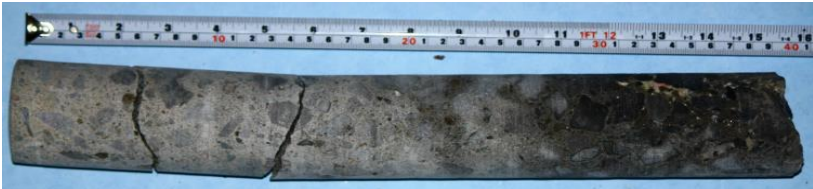
335 **Table 2**
 336 Coring samples and their properties.

Sample Code	Depth (cm)	Moisture Content (%)	Sample Image	Cross Section
PK 35-903	43.5	22

PK 35-902	40	86

322 cooled. But, in order to prevent the water from confounding the moisture measurements, the
 323 drilling process was limited to only 10 minutes for each core. During this time the water cannot
 324 penetrate through the specimen and cause erroneous results, and since the coring was taking place
 325 in the vault, the water was dripping all through the process, which render it impossible to wetting
 326 the specimen. Table 2 summarizes the five samples and their properties. As demonstrated, coring
 327 test results of samples PK 35-902, PK 35-896, and PK 35-895 indicated high percentages of
 328 moisture content, recorded as 86, 74, and 65 respectively. These wet samples can also be noticed
 329 from their images and cross sections in Table 2. These results perfectly correlated with GPR-IBA
 330 for these three samples as located in the water void (red) zone on the map. While the moisture
 331 content percentages for samples PK 35-903 and PK 35-898 were found to be 22 and 19

332 respectively. Hence, they were categorized as dry samples, which correlated very well with GPR-
 333 IBA result and sited in the air void (yellow) zone on the map. Furthermore, examining the images
 334 and cross sections of these two samples in the table reflect dry areas.
