Essentiality of Safety Sign for Children: A Case Study of Safety Issues in Hong Kong Playgrounds

2.2 The Selected Playground in the Study

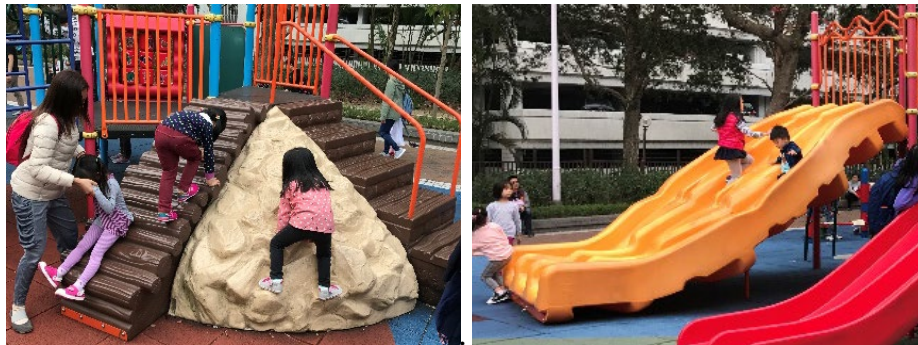
Fig. 3a-b. Potential dangers on the playground (photographs by authors)

One common safety issue was that children hit their heads on the fences or other railings of the facilities. For instance, Fig. 3a shows a composite play structure with a rock-like climbing structure. A girl found it challenging to climb on the structure. If she climbed to the highest step of the staircase, she might hit her head on the railing. Fig. 3b shows two sets of slides. Many children not only slid down, but also ran up the slides. They did not check whether other children were sliding down or running up when they played on the slides and could have easily knocked down other children on the slides.

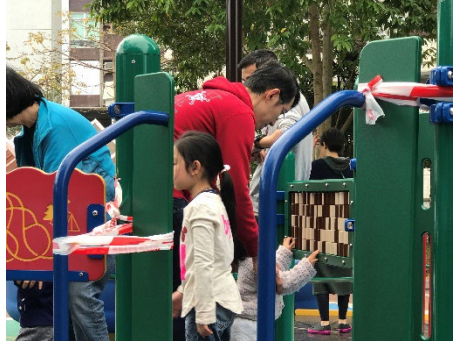
Fig. 4. A damaged railing on a composite play structure (photograph by authors)

Children played on damaged play facilities. Fig. 4 shows a railing of a staircase on a composite play structure. The children climbed up and down the play structure using the railing, which was damaged and could be dangerous to children if they put their full body weight on it. While there were other damaged facilities, the playground users seemed to be unaware of them.

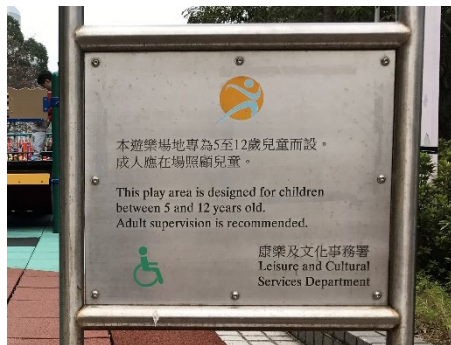
Fig. 5. A sign at the entrance to the playground (photograph by authors)

At the entrance of the playground, a noticeboard reminded the users that “adult supervision is recommended.” As suggested, caregivers accompanied their children at the playground. This close and intensive supervision helped prevent danger but also hindered children from playing more freely. In addition, there were more adults than children in the playground, with nearly two caregivers for every child. The playground was therefore very crowded, which may lead to other safety issues.

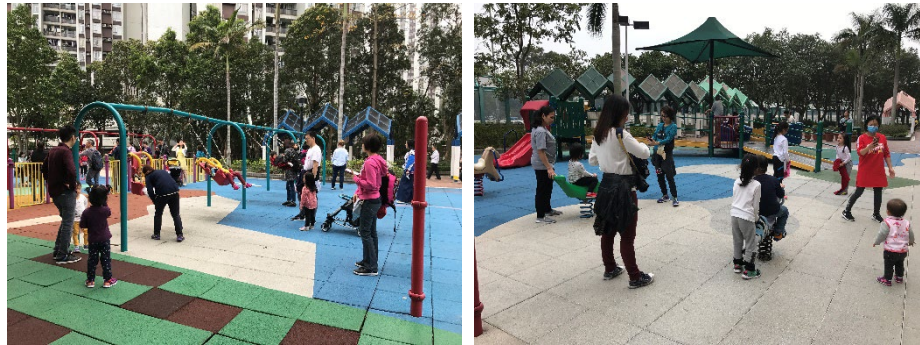
Fig. 6a-b. Caregivers, including parents and housemaids accompanying children at the playground (photographs by authors)

For instance, in Fig. 6a, caregivers stood in front of the swings looking after their children. Some of the caregivers were taking photos of the children, and others were pushing their children from behind or helping them to sit on the seats. Most caregivers were standing to the side and watching. Fig. 6b shows some children playing in the rocking chairs. Similarly, their caregivers were watching over the children playing. In the composite play structure areas, most caregivers followed their children onto the play structure and provided help when needed. Some adults even blocked the way on

the composite play structure, and children who were running could collide with the adults' legs. From what was observed, not all of the caregivers were needed in the playground to provide care to the children. This excessive care could hinder children from playing freely and developing problem-solving skills. It also made interactions with other children difficult, as caregivers would often interfere in the play process.

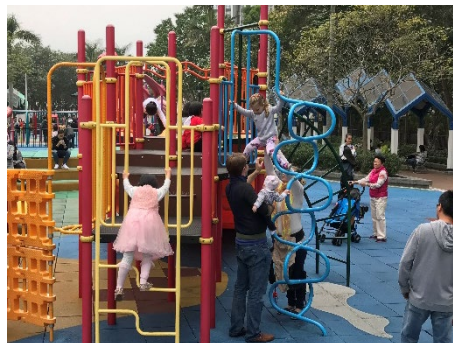
Fig. 7. Western parents assisting their daughter at the playground (photograph by authors)

However, care was necessary when children were in potential danger. For instance, when children climbed too high and challenged themselves to climb higher, it was necessary to provide assistance. Fig. 7 shows a pair of parents helping their daughter to climb up the composite play structure. The child had climbed higher than the height of the adult, and the parents were teaching her where she should put her hands and legs so that she could move to the platform of the composite play structure. While this play facility was too challenging for the child given the gap between the climbing frames and the platform, she succeeded with her parents' help.

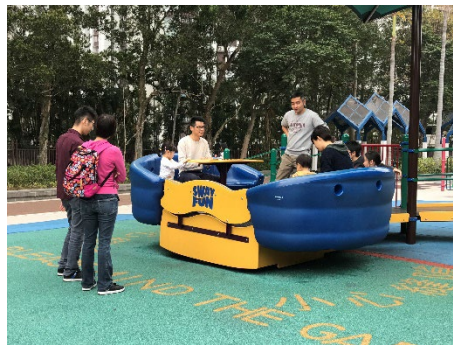
Fig. 8. Safety message on the rubber floor of the play area (photographs by authors)

However, in the selected playground, there were no safety signs related to the play facilities. The only safety message related to the play facilities appeared next to the see-saw ship, as shown in Fig. 8. The message “Please mind the gap” was displayed on the rubber floor of the play area. This was used to warn playground users not to be trapped by the gap between the ship and the group. Obviously, this message was not for children, as it used difficult vocabulary (縫隙). Safety signs would be more effective than textual safety messages for children [6], and it is unknown why safety signs designed specifically for children are not present at the playground.
