# **Structural Condition Assessment of Asphalt Pavement Semi-Rigid Bases Using FWD Deflection Basin Parameters**

Assessing structural conditions of semi-rigid bases in asphalt pavements is essential for effective base treatment in reconstruction and expansion (R&E) projects. Although various falling weight deflectometer (FWD) parameters have been developed for this purpose, field-validated parameters are still missing. This study identifies the appropriate FWD deflection basin parameter (DBP) through sensitivity analysis, correlation examination, and on-site milling and inspection. Findings indicate D20-D60 as the most suitable DBP, with 23  $\mu\text{m}$  and 40  $\mu\text{m}$  thresholds for warning and severe conditions, respectively. The correlation between D20-D60 and cracking rate suggests that high cracking rates suggest base weakness, whereas low rates may not guarantee structural integrity due to maintenance masking effects. On-site milling further confirmed this finding, demonstrating the alignment between D20-D60 assessments and field observations. The outcome of this study is anticipated to provide a practical DBP for evaluating semi-rigid base conditions and to inform

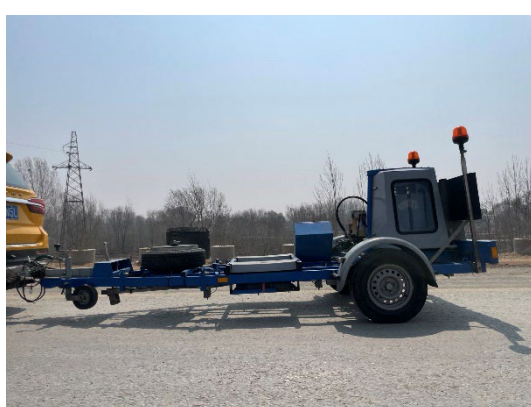
Figure 1 Schematic diagram of FWD deflection testing

FWD tests simulate the effect of a moving wheel load by dropping a known weight from a specified height onto a circular loading plate placed on the pavement surface to generate an impulse load (Ministry of Transport of the People's Republic of China, 2019). This action generates a deflection bowl, a measurable deformation pattern that reflects the pavement's response to the load, as shown in Figure 1. The deflections are recorded by sensors placed at various distances from the load plate, providing detailed data on the pavement's stiffness and structural condition. A sensor should be placed at the center of the loading plate, with additional sensors arranged linearly from the center, typically distributed within 250 cm. For back-calculating the modulus of the pavement structure layer, a minimum of seven sensors (preferably nine) are required, including positions at 0 cm, 30 cm, 60 cm, and 90 cm (Ministry of Transport of the People's Republic of China, 2019). Each measurement point is tested at least three times. The first drop is considered a preparatory drop and discarded due to the unstable contact between the loading plate, deflection sensors, and the pavement (Ministry of Transport of the People's Republic of China, 2019). The load and deflection data from the second and subsequent drops are recorded to ensure statistically meaningful averages.

(a) FWD

(b) Deflection basin curve

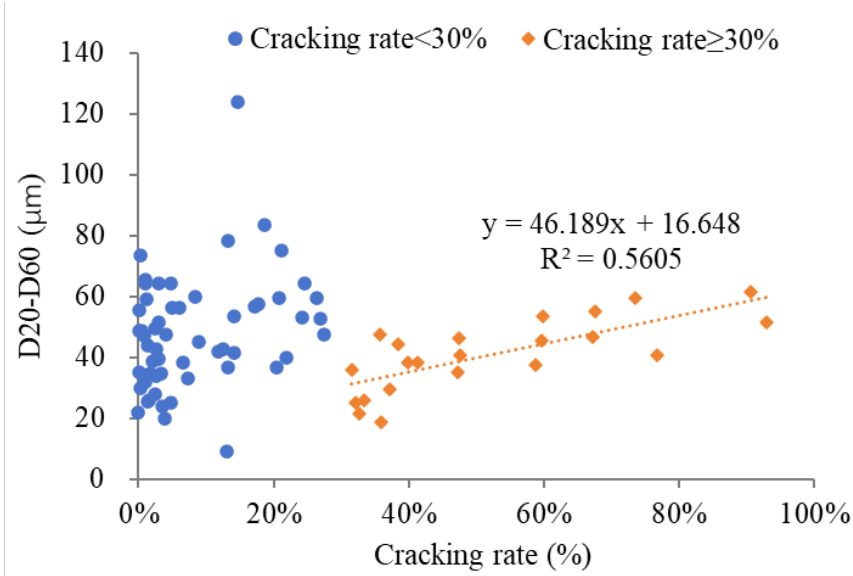
Figure 8 Correlation between  $D_{20}-D_{60}$  and cracking rate

Figure 8 presents the correlation between  $D_{20}-D_{60}$  and the cracking rate. There is a positive linear relationship when the cracking rate exceeds 30%, but no significant relationship when the cracking rate is below 30%. A survey of pavement maintenance histories revealed that many sections with a cracking rate below 30% had undergone maintenance. Therefore, it can be concluded that while a high cracking rate can indicate insufficient base strength, low cracking rate does not necessarily imply an intact base structure, as pavement maintenance can restore surface conditions. This also demonstrates the importance of condition assessment of in-service base structures.

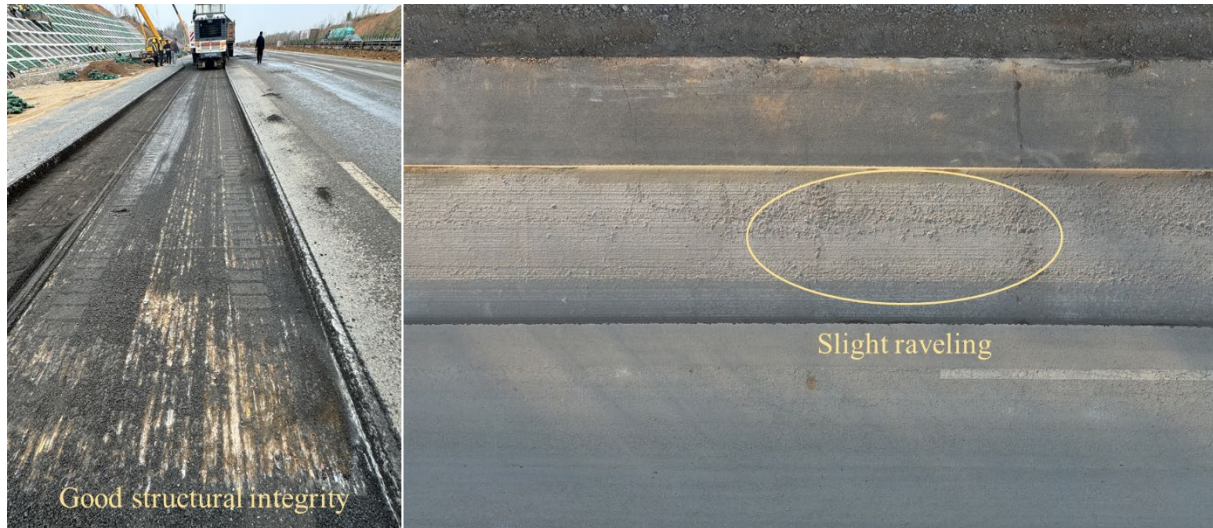
Figure 10 Structural condition of section 2

Figure 10 shows the condition of base layers in Section 2. It can be observed that road sections with lower  $D_{20}$ - $D_{60}$  values correspondingly have good structural integrity in the base layer. In contrast, the  $D_{20}$ - $D_{60}$  value for one test point greatly exceeds the severe threshold, and the corresponding base layer shows slight raveling. This observation further validates the reliability of the  $D_{20}$ - $D_{60}$  parameter for evaluating the structural condition of the base layer.

Section 2 is located in the driving lane. The FWD deflection test results for this section are presented in Table 4, with blue, orange, and red fonts representing sound, warning, and severe levels, respectively. Overall, the  $D_{20}$ - $D_{60}$  values for this section are relatively better than those for Section 1. Most of the  $D_{20}$ - $D_{60}$  values fall within the good or warning levels, with only one test point reaching the severe level.
