1  
2 **Microstructural Material Characterization of**  
3 **Hypervelocity-impact-induced Pitting Damage**

17  
18 **Submitted to *International Journal of Mechanical Sciences***

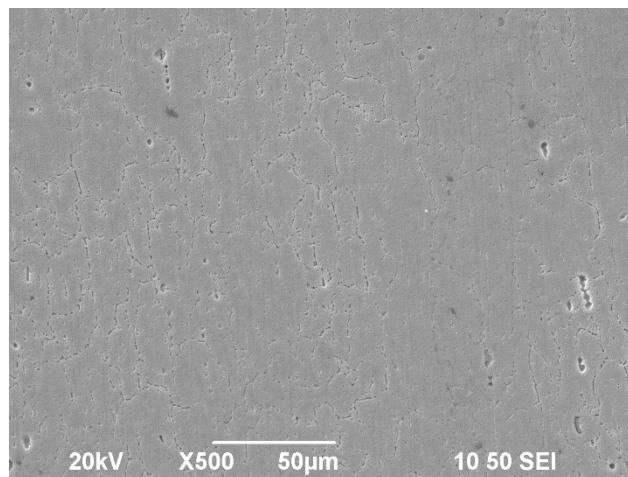
149 **Fig. 2. SEM (JEOL JSM-6490) image of the base metal 5A06 alloy.**

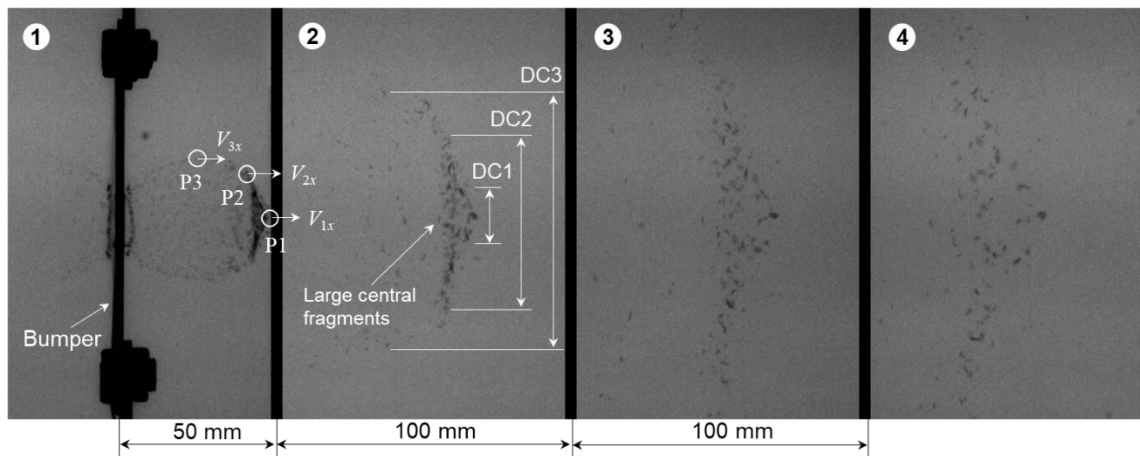
**Fig. 3.** X-ray images showing the formation and expansion of debris cloud under normal HVI.

173 Under normal HVI, the debris cloud is distributed symmetrically with a slow radial expansion,  
174 as observed in Fig. 3 and illustrated schematically in Fig. 4(a). The cloud comprises three  
175 major parts, namely an *ejecta veil*, an *external bubble debris*, and a *significant internal*

232 (1) when the initial velocity of the projectile is 4.13 km/s, primary craters (with a diameter  
 233 close to the thickness of the rear wall) are mainly concentrated in  $D_{cc}$  (because majority  
 234 of the large debris particles align in the center of debris cloud, as shown in Fig. 3); most  
 235 sub-craters (with diameters between 1 mm and the thickness of rear wall) are in  $D_{rc}$ ; and  
 236 micro-craters (with diameters between tens to hundreds of microns) broadly scattered in  
 237 all  $D_{cc}$ ,  $D_{rc}$  and  $D_{99}$ , as revealed by Fig. 5(left). Fig. 7 shows the profiles of three  
 238 representative pitting craters in  $D_{cc}$ ,  $D_{rc}$  and  $D_{99}$ , respectively measuring  $\sim 2.3$  mm,  
 239  $\sim 1.1$  mm, and  $\sim 0.5$  mm. The diameters of most pitting craters are larger than those of the  
 240 debris particles (10~100  $\mu\text{m}$ ), which can be attributed to the fact that the material in the

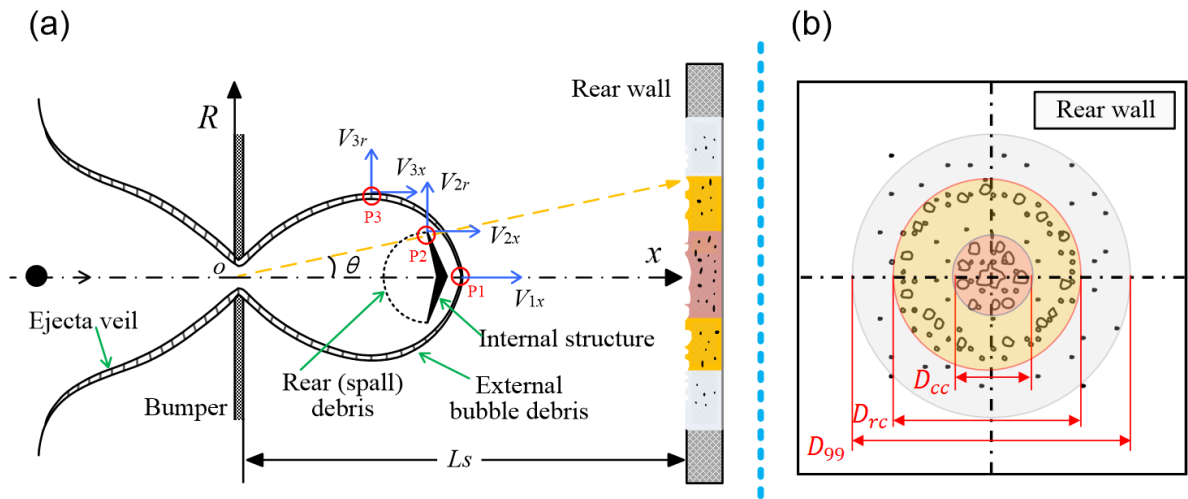
176 structure (including a front, center and rear element). As observed, numerous particles are  
 177 concentrated in the internal structure at the front of the bubble debris, with majority of large  
 178 central fragments in the center element. The debris cloud further impinges the rear wall layer,  
 179 and its front element, center element and external bubble debris jointly introduce  
 180 multitudinous, disorderedly scattered pitting craters and cracks in the rear wall. The pitting  
 181 damage area can be broadly classified into three areas: *the central cratered area* ( $D_{cc}$ ), *the*  
 182 *ring cratered area* ( $D_{rc}$ ), and *the spray area* ( $D_{99}$ ), respectively, as interpreted in Fig. 4(b).  
 183 These three damage areas contain 99% of the pitting craters and cracks.

184  
 185 **Fig. 4.** Normal HVI case: (a) schematic of debris cloud structure; and (b) schematic of debris cloud-  
 186 engendered pitting damage area in the rear wall layer ( $L_s$ : shield spacing).

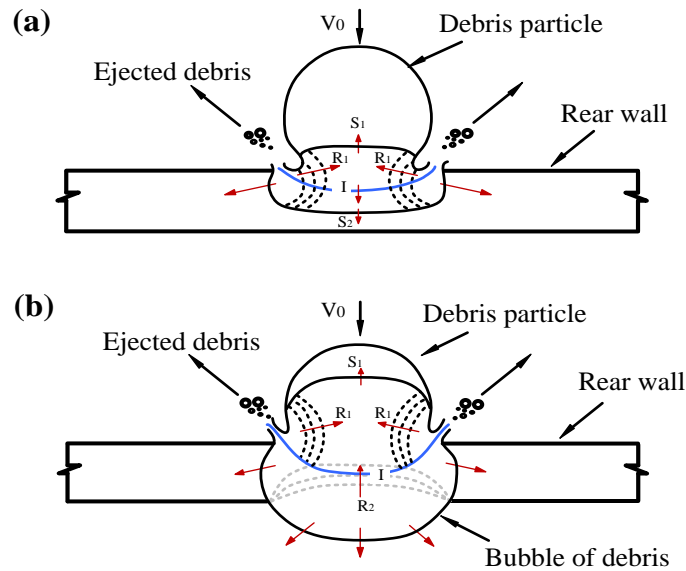
489 During the debris cloud impinges the rear wall, shock wave will be generated in all the debris  
 490 particles and the rear wall plate as well. Let  $S1$  denote the shock wave propagating in a debris  
 491 particle and  $S2$  the wave in the plate, as illustrated schematically in Fig. 20(a). The high  
 492 pressure associated with shock wave propagation is typically several orders of the material  
 493 strength of the plate. As a result, both the debris particle and plate will be severely compressed  
 494 and materials intend to remain their original status, consequently generating tensile-type

495 unloading wave ( $R1$ ). If the tensile stress of  $R1$  is higher than that of the particle or plate, the  
 496 material of the particle or plate will be shattered and spatter out, leading to the formation of a  
 497 thin outer fringe around the mouth of the crater. Simultaneously, tensile-type damage such as  
 498 dimples, micro-voids and micro-cracks, will be engendered in the rear wall adjacent to the  
 499 craters, as seen in Figs. 9 and 11. However, the shock wave  $S2$  will be reflected from the back  
 500 surface of the plate to create a tensile-type shock wave  $R2$ , as shown in Fig. 20(b). Due to the  
 501 tensile effect of  $R2$ , the material near the back surface of the plate will “swell”. Spall and  
 502 protuberance will be induced if the stress of  $R2$  is lower than the tensile strength of the material  
 503 of the plate whereas higher than the limit of spall [35].

505 **Fig. 20.** (a) Debris cloud-induced shock waves in a debris particle and the rear wall; and (b) shock wave  
 506 reflected from the back face of rear wall.
