Seismic vulnerability and inventory of at-risk elements in the wine industry: Auckland region case study

Olabode E. Ogunmakinde^a, Temitope Egbelakin^b, Temitope Omotayo^{c,*}, Adebayo Sojobi^d

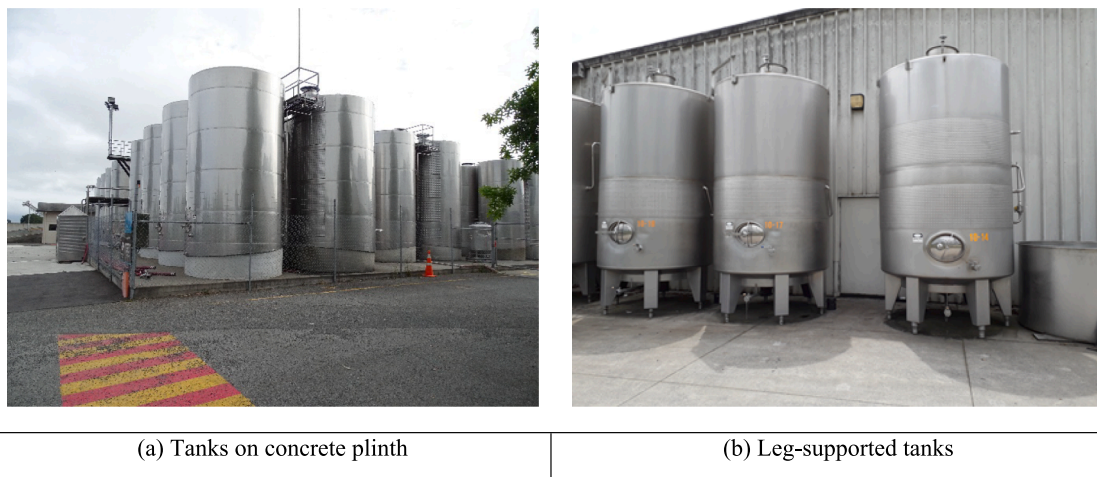
Compared to other winery structures, storage tanks typically experience higher levels of failure during earthquakes [11]). While steel tanks are preferred in the wine industry, they are more prone to earthquakes than concrete tanks [20]. Plinth-mounted and legged tanks are two types of tanks with different methods of failure [16,33]. The type and capacity of the tank are important factors when determining vulnerability. Sometimes the tank's design is a 'weak link' in the failure of the wine tanks [11]. Plinth-mounted tanks (see Fig. 1a) with 60,00–300,000 L capacities are installed on a concrete base [24]. Plinth tanks suffer damage to anchorage systems, walls, skirts, and connection points, while the most common damage to the plinth tanks is anchor failure. Leg-mounted tanks (see Fig. 1. b) typically have a capacity of 5,000–60,000 L and are generally supported by a frame system [24]. The performance of the leg-supported tanks showed that these tanks sustained damage to the legs, tank skirt, bracing, roof and storage systems. According to Dizhur et al. [11], the extent of damage sustained in storage tanks depends on the size and design of the tank.

Fig. 1. Two different tank types.

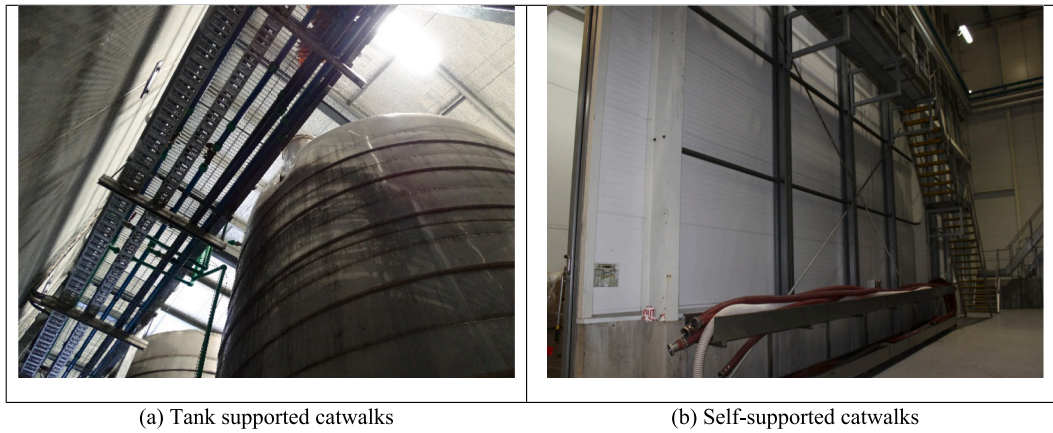
Catwalks (Fig. 2) are access systems easily damaged by their connection to the storage tanks [24]. Determining the vulnerability and level of damage depends on whether the tank supports the catwalks (see Fig. 2a) or self-supported (see Fig. 2b) [11]. Self-supported catwalks showed almost no signs of damage, only minor denting during the past earthquakes [33]. On the other hand, Tank-supported catwalks showed large amounts of damage, especially in systems where no movement was made between the connection points of the tank and the catwalk [33]. Catwalks are directly linked to storage tanks, and damage to one of these elements usually damages the other [11]. As catwalks are expected to be designed by an engineer and have the approval to build, it is unlikely they will be used in smaller wineries.

Fig. 2. Catwalk types commonly used in the wineries.

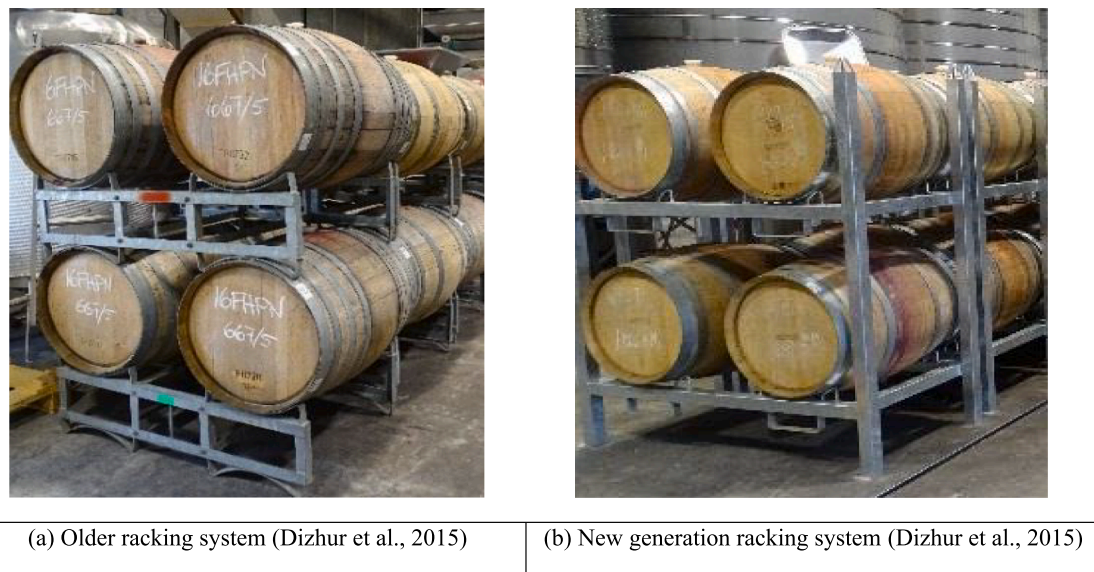
South Napa earthquake [17]. Occasionally, wooden rails are used to store barrels and perform the same function as the old steel rack, as described by Dizhur et al. [11], which implies that wooden and old steel rack systems have limited seismic resilience. New structural design standards for barrel racks have recently been introduced in New Zealand, resulting in a more robust rack design [11]. The performance of the old and new storage rack design was observed in the Kaikoura earthquake of 2016, where the older design system (see Fig. 3a) experienced failure. In contrast, the newer rack system, a kind of seismic reinforced design (Fig. 3b), experienced only limited movement [11].

Fig. 3. Two generation of racking system.

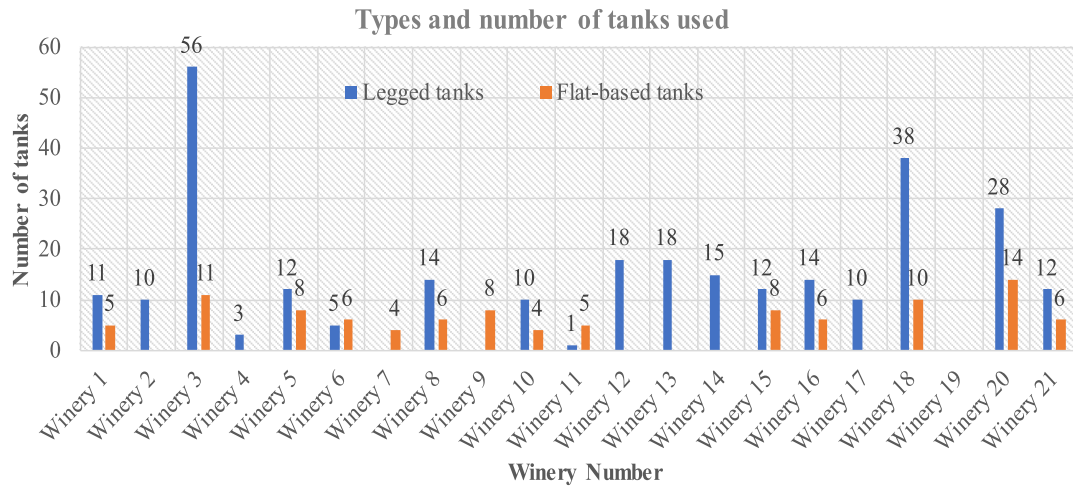
In wine production, legged tanks (Fig. 5) and plinth-mounted tanks are commonly used. According to the wineries surveyed, the majority (80 %) used Legged tanks (see Fig. 6). It should be noted that winery 19's storage tank type was not disclosed. However, the majority of the tanks in the research area are housed indoors (see Fig. 7). This contradicts Rosewitz and Kahanek's [33] findings that storage tanks in the Marlborough region are mostly located outside. The shape of the storage tanks varied between wineries (Fig. 8), with slender tanks being the most common (48 %). Winery 01 used only one timber storage tank, and

Fig. 6. Type of storage tank used in wineries.

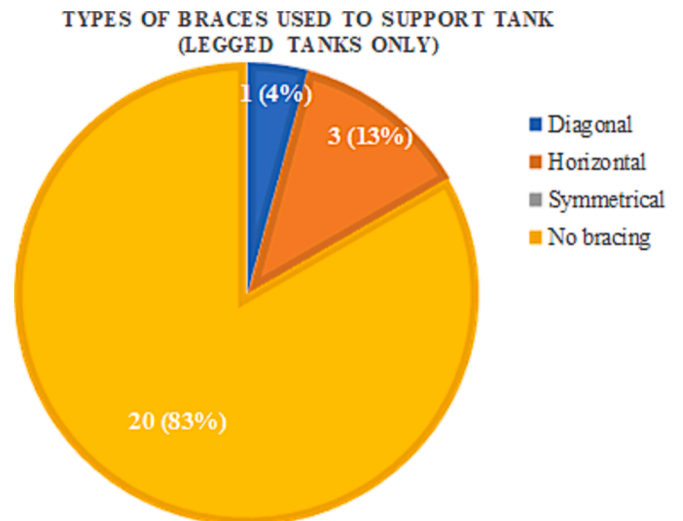
individually or in groups. In winery 03, for example, the three types of bracing were combined. Fig. 10 shows that the majority of legged tanks (83 %) lacked a bracing system. Only 17 % of the wineries used bracing in their tank designs. Tank legs of various materials, including wood, plastic, and steel, were seen in the wineries.

Fig. 10. Type of braces used for the legged tanks.

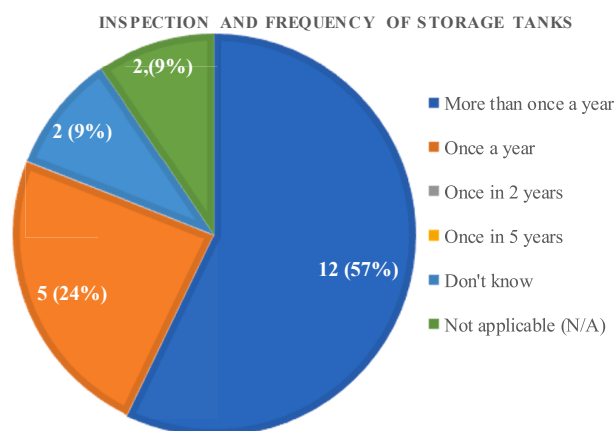
Fig. 11 shows that 57 % of the tanks in the wineries were inspected more than once a year. Following that, the installation period of the storage tank was determined. Fig. 12 shows how many years have passed since the storage tanks were installed. According to the data, eight wineries installed their storage tanks between 11 and 20 years ago, five wineries installed them more than 20 years ago, four wineries installed them between six and ten years ago, and three wineries installed them less than five years ago. Only one winery installed a storage tank in the last few years. According to the findings, most wineries installed their storage tanks around the time they opened for business. One of the wineries had a storage tank with a flat bottom and base plates. Base plates are used to secure storage tanks to the ground, usually on a concrete plinth. Except for one (winery 06), which had a few tanks on the base plate, none of the wineries secured the tank base plates to the ground. The flat-based tanks at Winery 06 typically had four points of attachment to the storage tanks. According to Dizhur et al. [11], the bracing method, anchorage, shape, and capacity are the most important factors to consider when determining the vulnerability of storage tanks. As a result, this information was included in the final inventory.

Fig. 11. Inspection and frequency of tanks.
