RESEARCH ARTICLE

Polymer
COMPOSITES

Hygrothermal aging effects on the mechanical behaviors of twill-woven carbon fiber composite laminates with flame-retardant epoxy resin

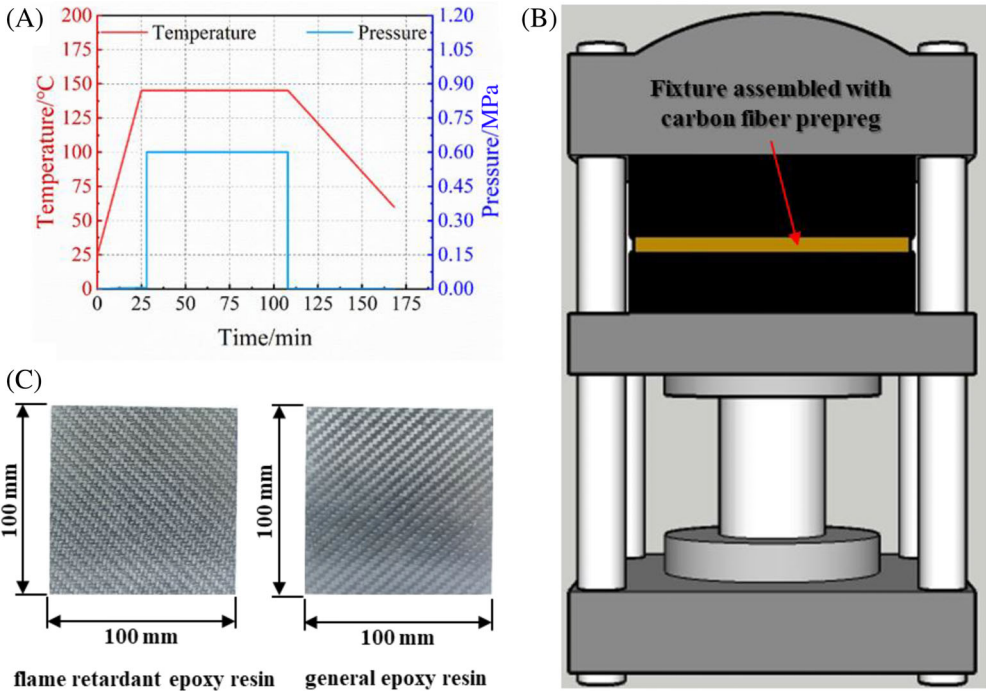
FIGURE 1 Fabrication of laminates: (A) cure conditions, (B) schematic of hot-press, (C) laminate samples.

The specimens used in the experiments were fabricated from twill-woven carbon prepregs (T300-3 K carbon), as detailed in Table 1. The prepregs utilized both general and flame-retardant epoxy resin as the matrix materials. To fabricate the specimens, 24 layers of twill woven carbon fiber prepreg, incorporating with these two kinds of epoxy resin, were stacked in the same direction and placed into a mold. The curing process involved heating from 25°C to 145°C at a pressure of 0.001 MPa, followed by an increase in pressure to 0.005 MPa for 3 minutes, and then to 0.6 MPa for 80 min, as detailed in Figure 1A. After natural cooling to room temperature, the plates were cut into specimens measuring 100 mm × 100 mm × 4.8 mm (Figure 1C). The laminates made with general epoxy resin and flame-retardant epoxy resin are abbreviated to CF_G and CF_FR, respectively. To ensure the reliability of the data, each test was conducted at least three times.

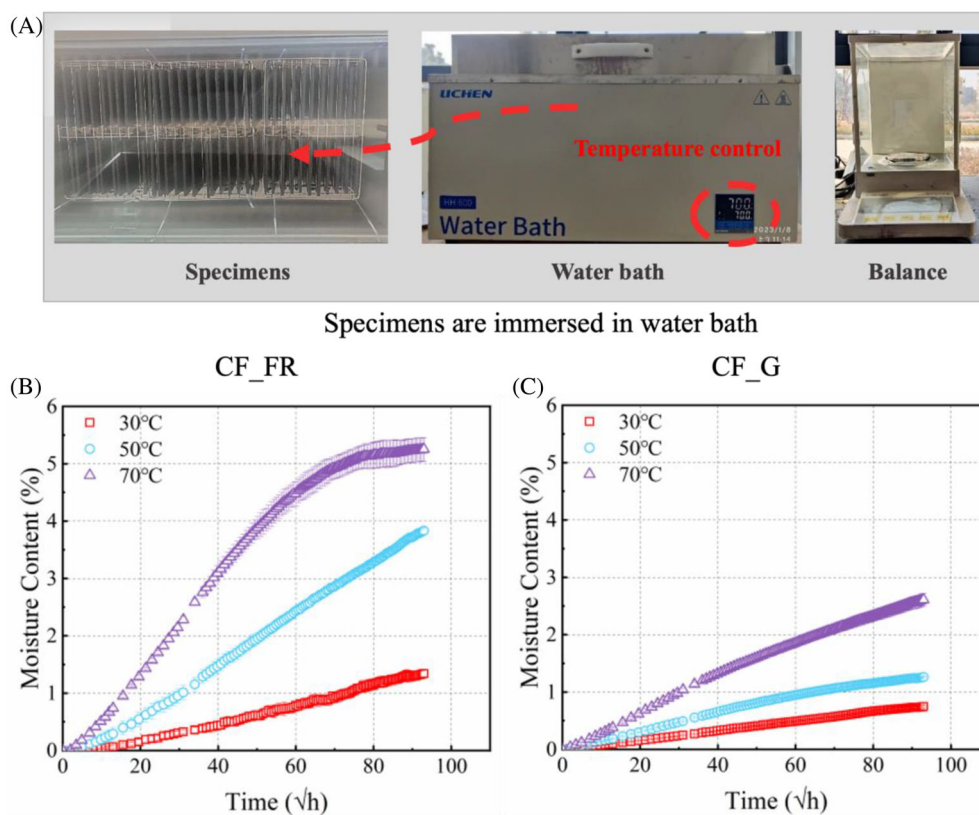
FIGURE 3 Moisture absorption behavior: (A) Specimens in water bath; (B) CF_FR and (C) CF_G specimens exposed to water with different temperatures for 360 days.

To investigate the moisture absorption behavior of composite laminates, specimens were immersed in water baths at different temperatures, as shown in Figure 3A.

The moisture absorption curves in Figure 3B,C show an initial linear increase in moisture content relative to the square root of time, indicating that moisture is easily absorbed into the epoxy resin during the early stages. Subsequently, the rate of moisture absorption gradually decreases, likely due to the progressive occupation of unsaturated voids and water molecule-binding sites within the laminates. Eventually, the moisture content stabilizes. The final content of moisture absorption of both types of laminates at various aging temperatures is illustrated in Table 2. It is evident that the moisture content of the two types of laminates is noticeably affected by the temperature of hygrothermal conditioning. The

moisture content of CF_FR increases from 1.34% to 5.25%, and that of CF_G increases from 0.75% to 2.61% as the temperature rises from 30°C to 70°C. Notably, only the CF_FR specimens reached an effective moisture equilibrium after immersion in water at 70°C for 360 days. This clearly indicates that the moisture content of the CF_FR samples is substantially higher than that of the CF_G samples under the same hygrothermal conditioning, suggesting that CF_FR may be more susceptible to damage caused by hygrothermal aging due to their greater capacity for moisture absorption.

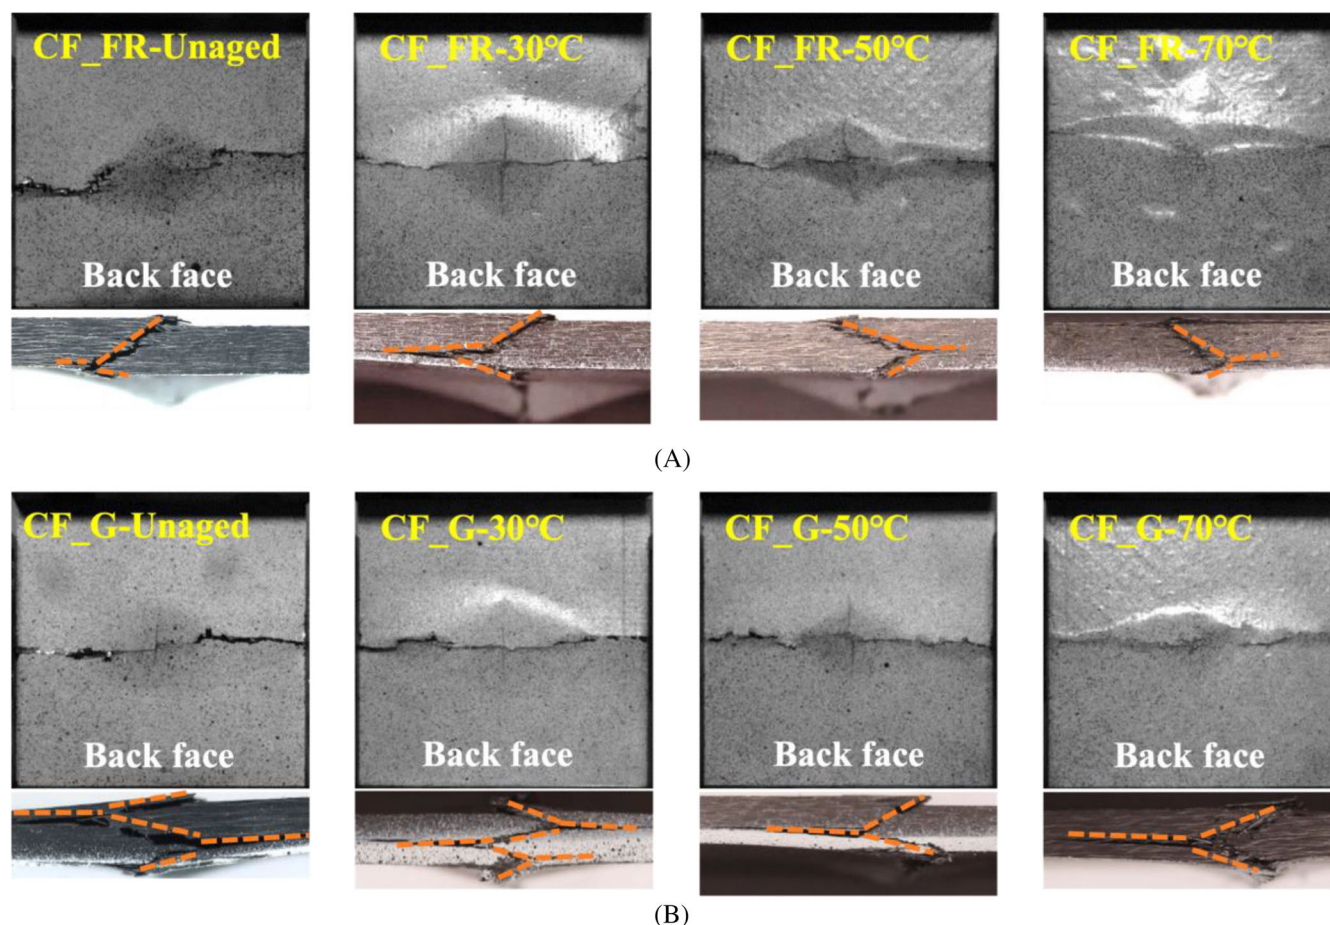
FIGURE 12 Compressive failure morphologies: (A) CF_FR under different hygrothermal conditions; (B) CF_G under different hygrothermal conditions.

Furthermore, the compressive failure morphologies of both laminates are presented in Figure 12. The temperature of the hygrothermal environment does not have a significant effect on the compressive damage morphology

of the laminates after impact. The compressive failure in both laminates is characterized by transverse cracks propagating through the impact-damaged area, extrusion damage of the carbon fiber, and the formation of shear cracks through the thickness.
