Two-Step Method for Instability Damage Detection in Tower Body of Transmission Structures

Abstract: Instability damage may occur in some members of the transmission tower subjected to the downburst, and eventually the damage accumulation may further lead to the failure of the tower. Therefore, it is extremely essential to identify and repair the damaged major vertical members in tower body timely. The relationship surface of instable member among axial compression force, bending moment at the end and axial stiffness is determined. The results show that the axial stiffness of the instability members reduces to zero gradually. Accordingly, a two-step detection method of the major vertical member instability damage is presented. The first step detection is used to find the possible buckling damaged regions by using wavelet packet energy curvature change rate index. The second step is used to identify location of buckling damaged major member that appears in the possible damaged subregions based on the theory of modal strain energy and interval estimation. Finally, the proposed method is applied to a realistic transmission tower and experimental verified with a steel tube tower. The r

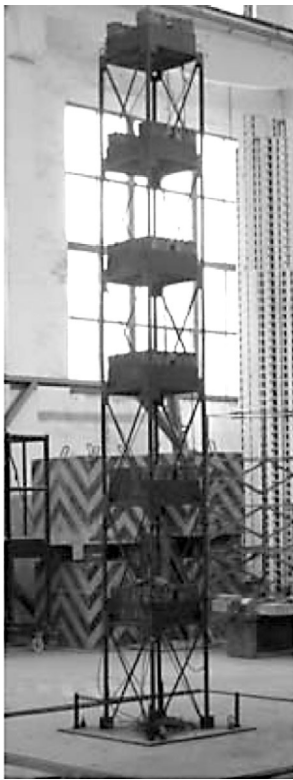
Figure 11. Tower model

steel tube with 16 mm external radius and 12 mm inner radius. The braces in x direction are made of solid circular steel with 3 mm radius, and the braces in y direction are made of solid circular steel with 7 mm radius. The beams are made of angle steel with 25 mm \times 4 mm, and each floor is made of steel plate with 10 mm thick. The beams, vertical members, and braces are welded to each other by small steel gusset plates (150 mm \times 65 mm \times 4 mm), and the floors are welded to the beams. The first four floors have 240 kg additional weight each, and the top two floors have 120 kg additional weight each. At the ground level,
