Contemporary Inspection and Monitoring for High-Speed Rail System

Lu Zhou, Xiao-Zhou Liu and Yi-Qing Ni

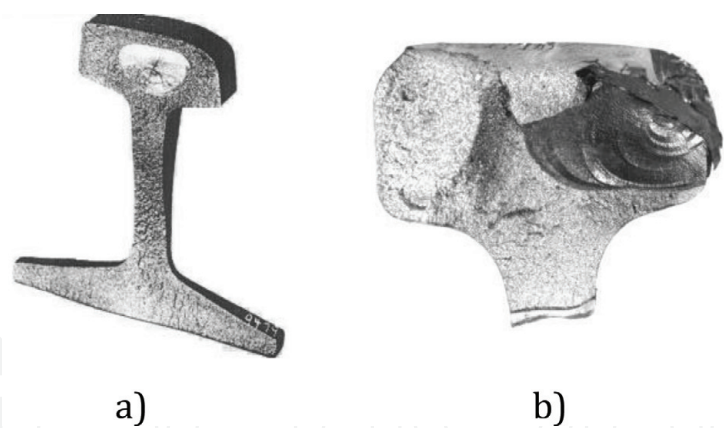
Figure 1.
Transverse defect and detail fracture [15]. (a) Transverse defect. (b) Detail fracture.

As per increasing of demand for HSR, rail defects have become a critical challenge in operation because an incident could cause more losses when trains run at higher speed. Many researchers have proposed classification methods for typical types of rail cracks derived from different propagation orientations of rail defects [15, 16]. The most common rail defects are caused by inappropriate manufacturing and inappropriate use of rails, and they mainly include transverse defects (TD), detail fractures (DF) and split heads. TD (**Figure 1a**) is one of the most critical type

of cracks that appear in railheads propagating along lateral direction. DF (**Figure 1b**) has an origination point and grows radially from the origination point. These types of defects are caused by inappropriate use such as excessive stress concentrations. The vertical split heads (VSH) (**Figure 2a**), which usually originate from manufacturing anomalies, cause the second most train derailments (after TD).

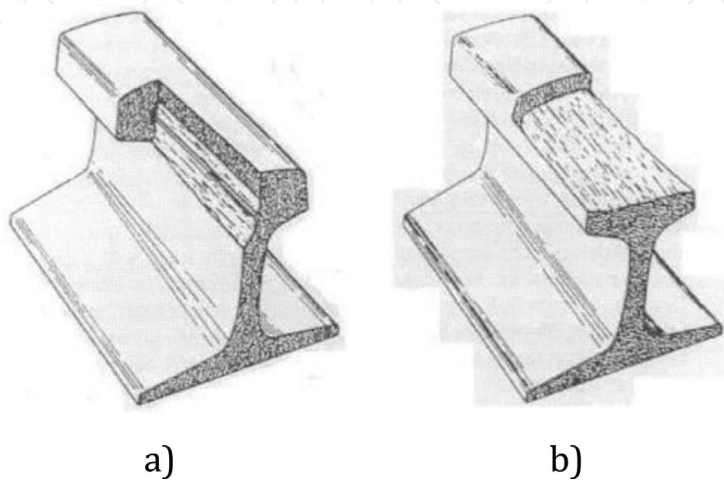
Figure 2.
Split head [16]. (a) Vertical split head. (b) Horizontal split head.

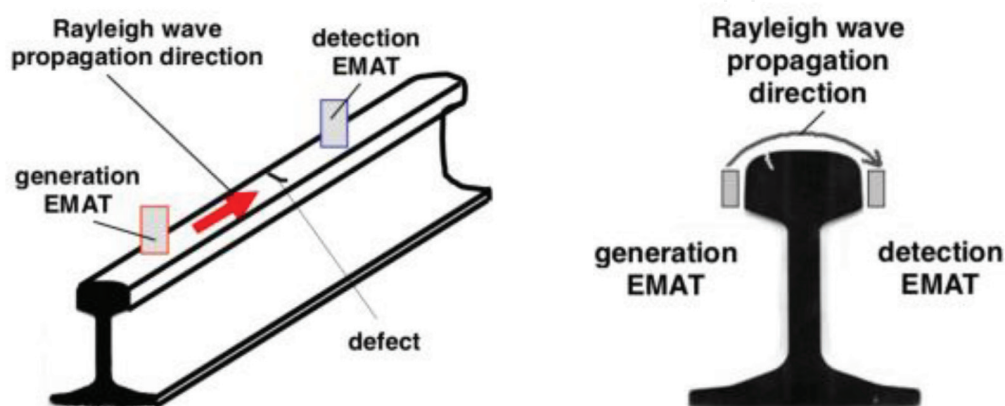
Figure 4.
Rail cracks detection using EMAT [59].

EMAT, as a kind of excitation and detection technique of propagating ultrasonic wave, can provide detection of defects located in subsurface area of railhead. Thus, a promising method appears to be electromagnetic-acoustic method which is realised by EMAT transducers. Both transverse and longitudinal cracks in railhead can be detected by using EMATs, as shown in **Figure 4** [59]. University of Warwick and University of Birmingham [60] developed a railway surface-detect inspection technique based on EMAT equipped with two EMAT converters, one for emitting surface Rayleigh waves and the other for receiving surface propagating Rayleigh waves. It is found that this technique can improve the inspection rate of horizontal and vertical defects on the railheads, compared with piezoelectric transducers. University of Warwick [61] designed a lab-based laser-EMAT system to investigate the ultrasonic surface wave's generation, propagation and interaction on the rail-head with a Michelson interferometer measuring the out-of-plane displacement. The Rayleigh-like wave generated by EMAT can flood the whole curve makes it capable to detect the gauge corner cracking.

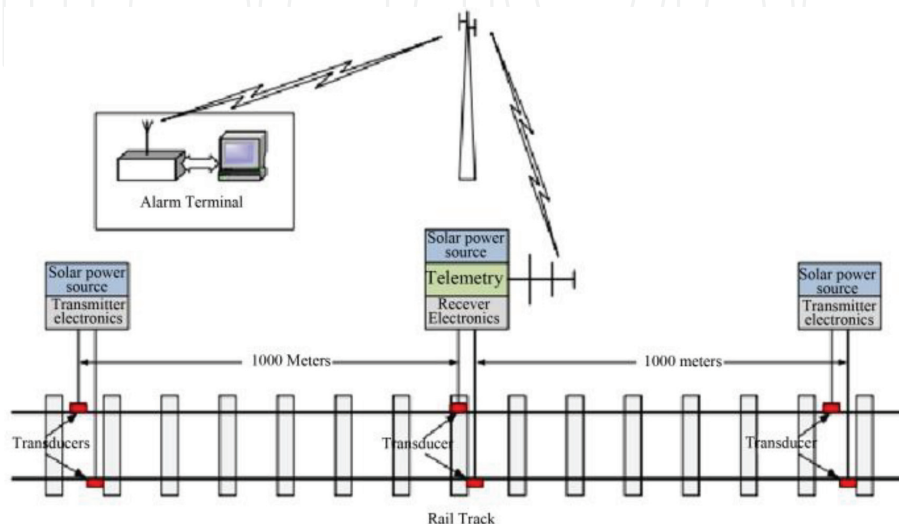
Figure 5.
Monitoring system on freight line in South Africa [66].

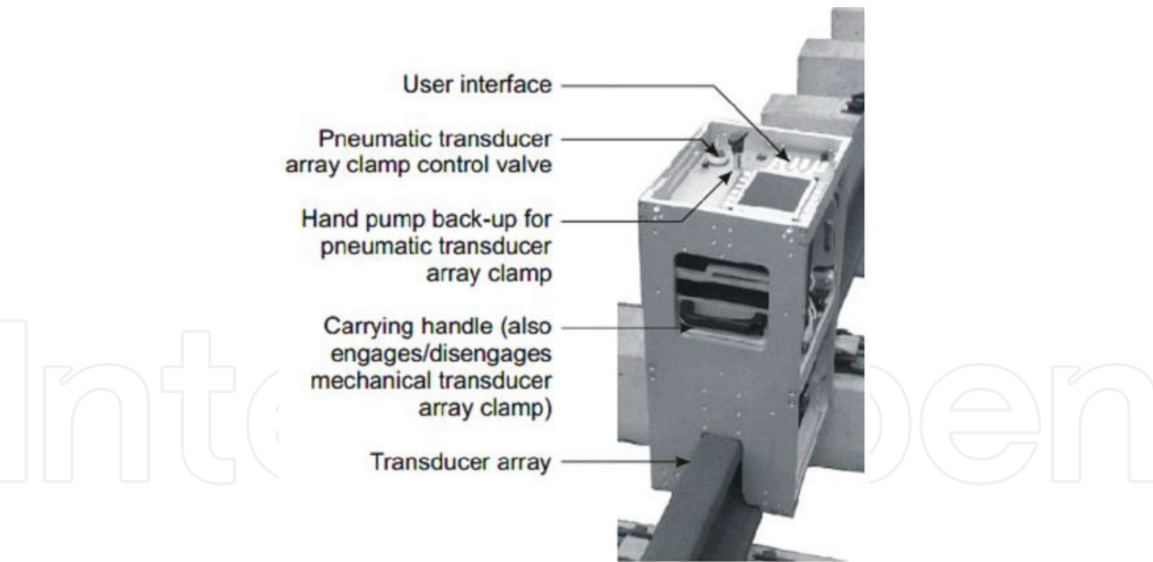
Figure 6.
G-type scan guided wave in inspection device in UK [67].

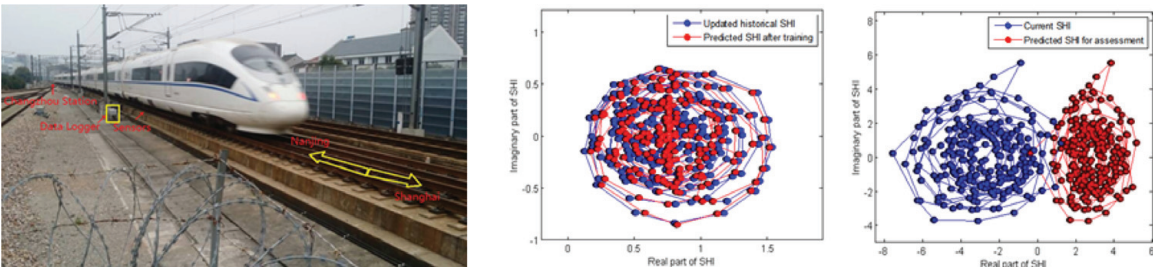
Figure 7.
(Left) Online HSR turnout condition monitoring system; (right) defect diagnosis method with model updating approach [70].

updating methods have been investigated dealing with great uncertainties arisen from the online monitoring data for more accurate and efficient damage diagnosis. AE method incorporating Bayesian framework is utilised in an online rail turnout crack monitoring system developed by CNERC-Rail [70]. The method is able to detect defects without training data of damaged rail structure and the monitoring systems have been implemented on Shanghai-Nanjing HSR lines, as shown in left panel of **Figure 7**. The rail turnout conditions are indicated in a probabilistic manner through a structure health index (SHI), as shown in right panel of **Figure 7**.

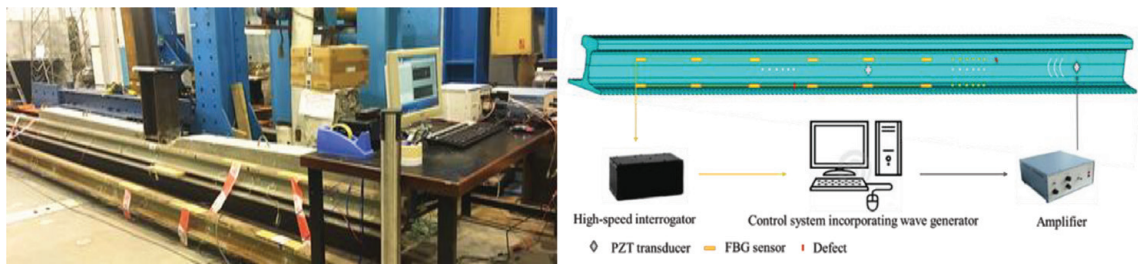
Figure 8.
 Schematic set-up of the FBG-PZT monitoring system [79].

FBG sensors for detecting acousto-ultrasonic signals have been studied since the mid-1990s [77]. The conventional interrogation technique for FBGs as sensing elements utilises their spectral encoding and decoding capabilities for the measurand; however, the spectral decoding capability cannot be used to detect high-frequency signals (e.g., acoustic and ultrasonic waves) due to the low wavelength scanning speed. Appropriate demodulation techniques capable of high-sensitivity detection of high-frequency waves are necessary to develop acousto-ultrasonic FBG sensors. There are two main approaches to detecting acoustic and ultrasonic waves with FBGs: the first one uses a narrowband light source to

illuminate the FBGs and demodulate the power intensity variation when the waves impinge on the FBGs, while the second one uses a broadband light source and an optic filter. Minardo et al. [78] conducted a numerical investigation on the response of FBGs subjected to longitudinal ultrasonic waves. Ni et al. [79] have developed a hybrid monitoring system using FBG sensors to interrogate ultrasound signals emitted by PZT sensors (**Figure 8**). The hybrid system has been verified in lab and a test line in mainland China.
