Cai Q, Chen Z and Zhu S (2022) Experimental study of influence line-based damage localization for long-span cable-suspension bridges. *ASCE Journal of Bridge Engineering*. 28(3): 04022151. <https://doi.org/10.1061/JBENF2.BEENG-5893>

# Experimental Study of Influence Line-based Damage Localization for Long-span Cable-suspension Bridges

Qinlin CAI<sup>1</sup>, Zhiwei CHEN<sup>2</sup>, Songye ZHU, M.ASCE<sup>3,\*</sup>

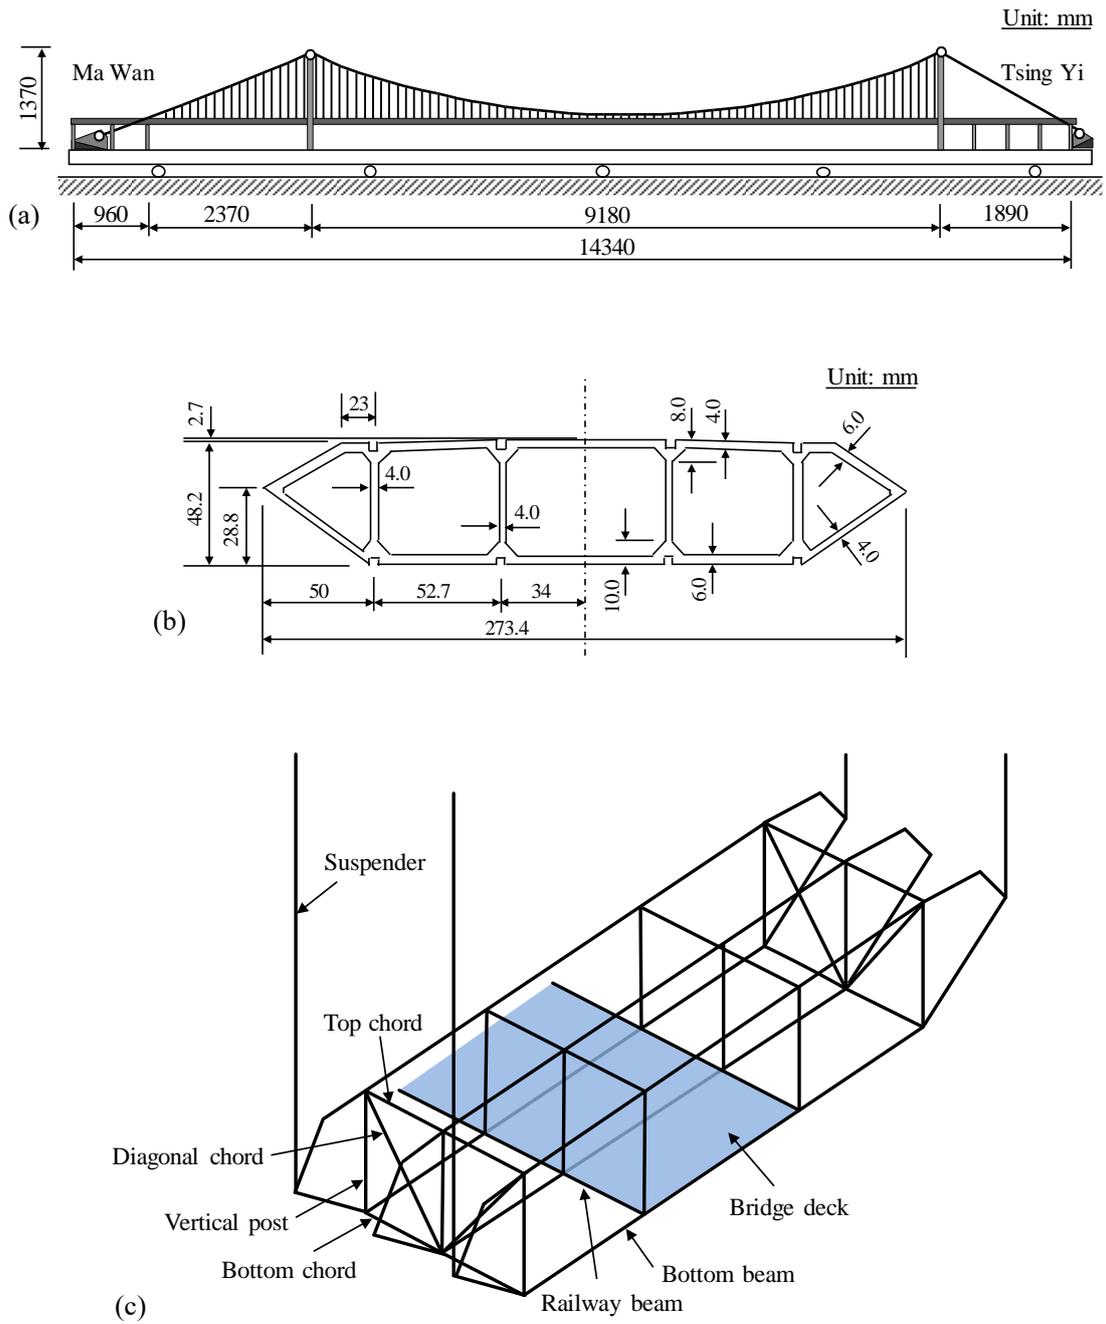
Fig. 1 Configuration of the TMB model: (a) Overview of the TMB model; (b) Cross-frame model; (c) Bridge components of two typical modules

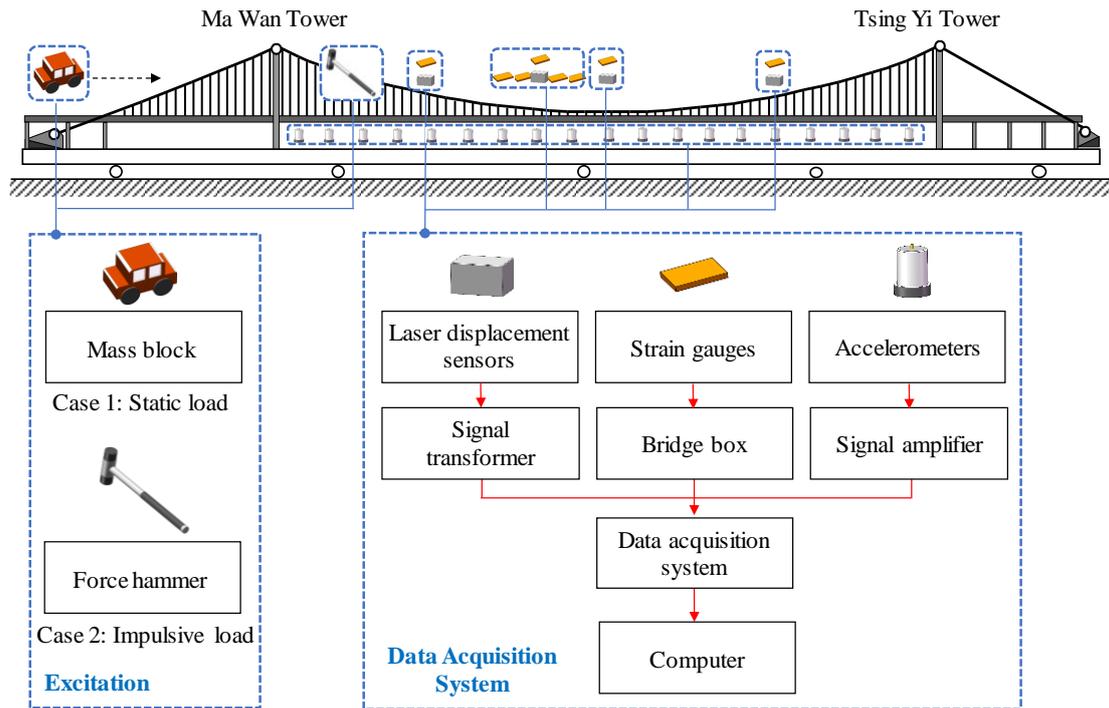
Fig. 2 Schematic of the experimental setup for the TMB model

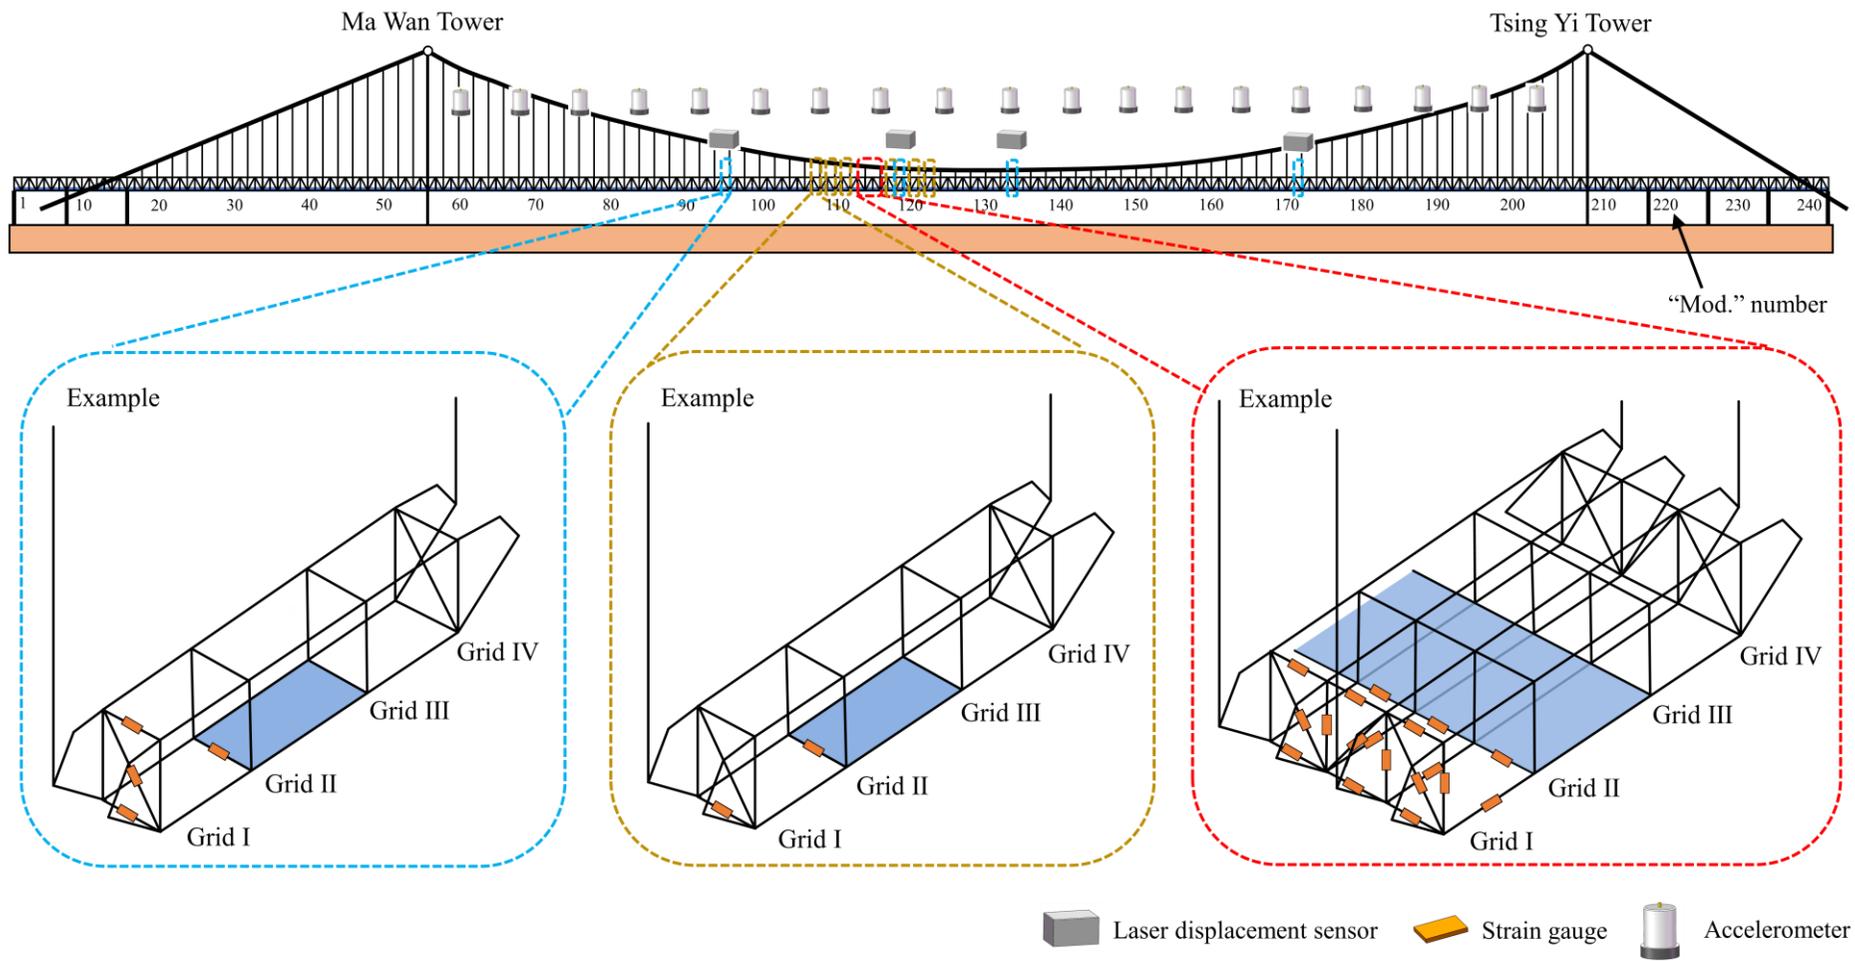
Fig. 3 Spatial configuration of the applied sensors in the TMB model (numbers “1” to “240” denote the Mod. number)

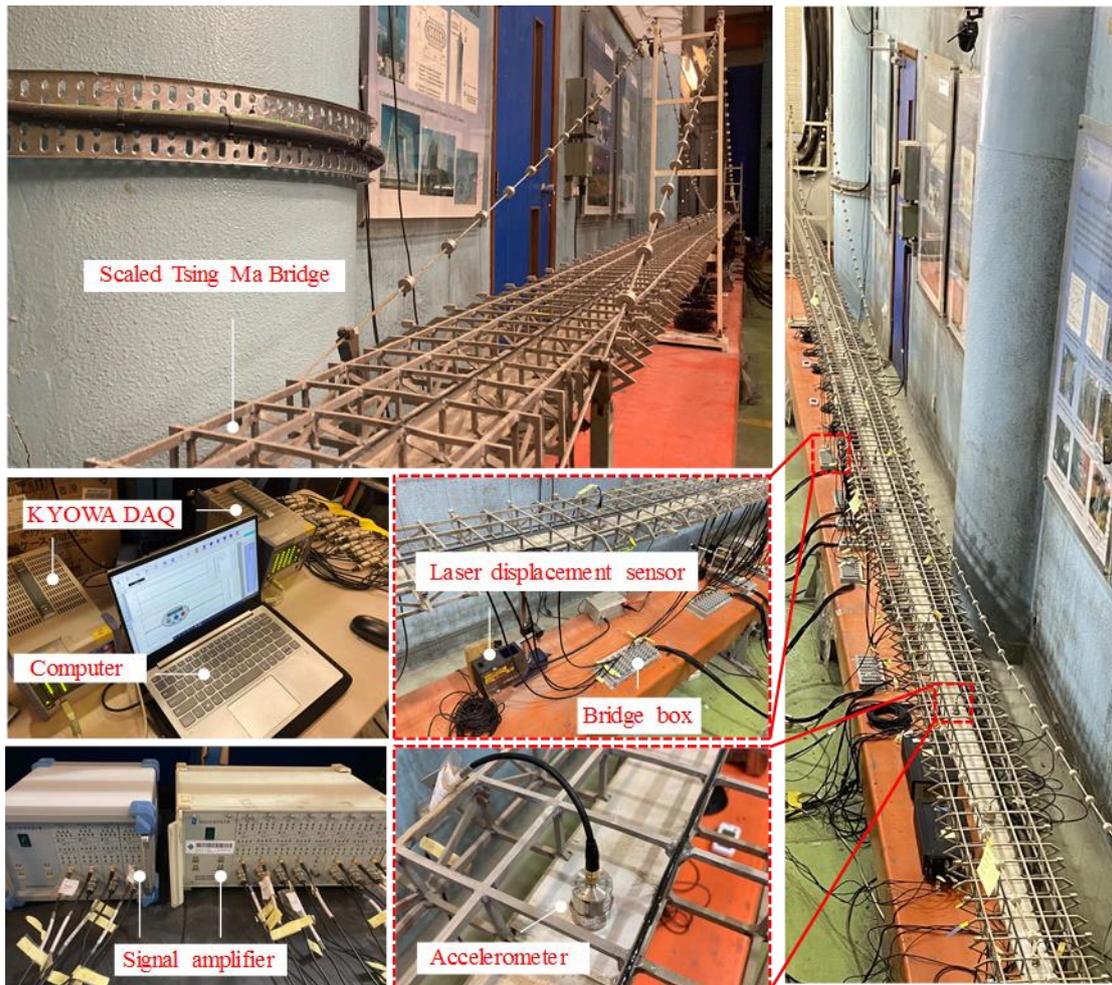
Fig. 4 Photograph of the experimental setup

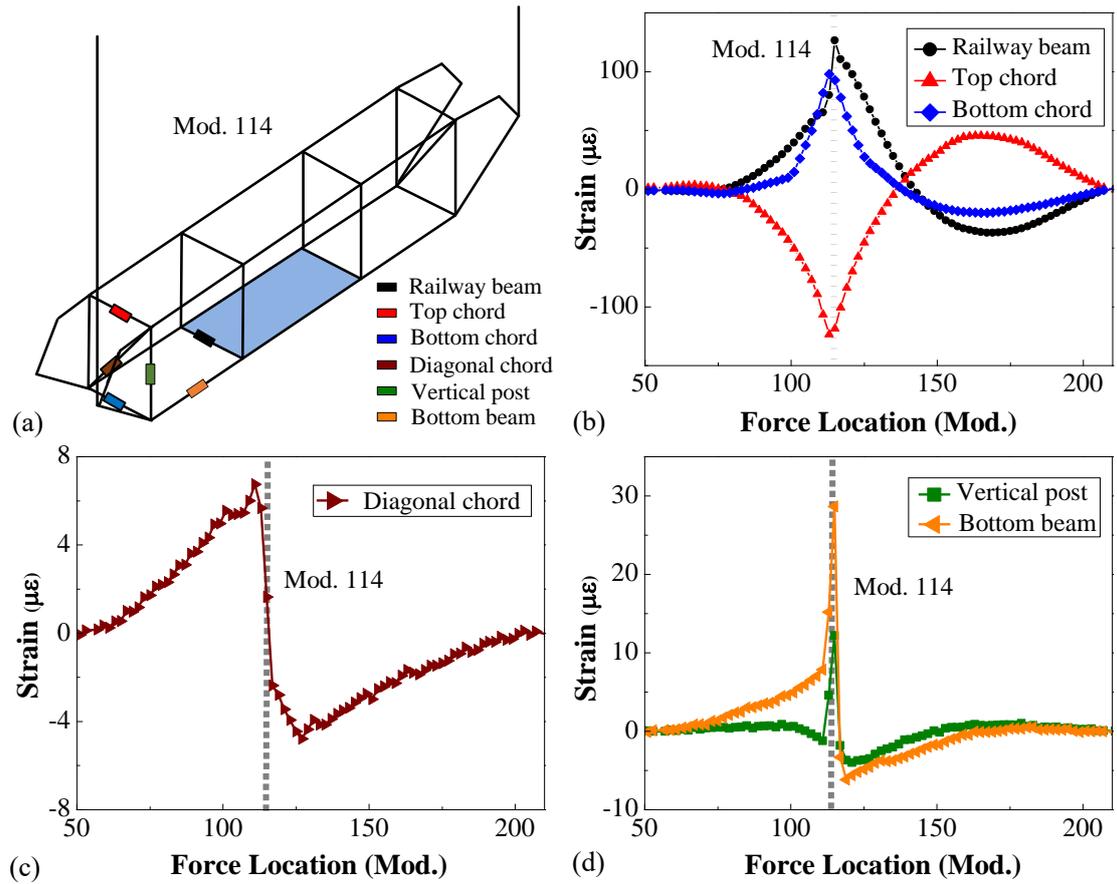
Fig. 5 SILs of different bridge components: (a) Component locations; (b) Set A; (c) Set B; (d) Set C

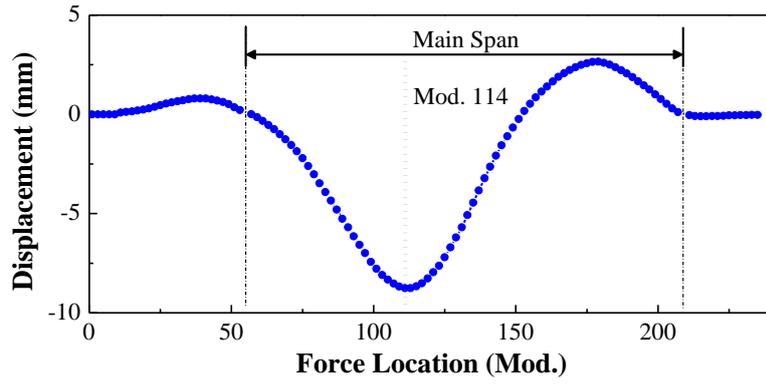
Fig. 6 DIL of bridge deck: Mod. 114

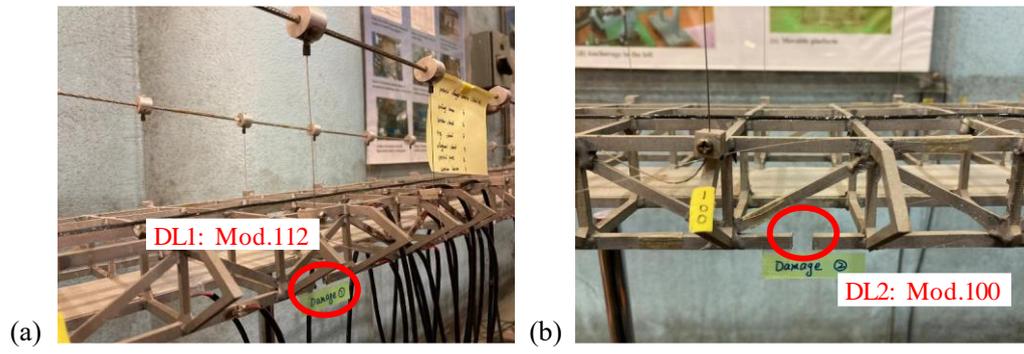
Fig. 7 Photograph of damage locations (DL is short for damage location): (a) DL1; (b) DL2

Given that the TMB is a statically indeterminate structure, any damage would result in the internal loading redistribution. Accordingly, the ILs, regardless of DILs or SILs, extracted from the undamaged components near the damaged members would also exhibit differences. Considering the components with relatively larger strain/stress amplitudes are more vulnerable to train- or vehicle-induced fatigue damage, the bottom chords member was selected as the damaged members in this study. The present study simulated two damage scenarios in the bottom chords, as seen in Fig. 7. Both were produced in Grid I, close to the strain gauge installation layout.

- The first damage scenario was made by cutting the bottom chord of Mod. 112, referred to as a single-damage case.
- The second damage scenario was simulated by cutting another bottom chord of Mod. 100, referred to as a double-damage case.

The bottom chords of the bridge are subjected to tension under a vertical external load. The two damaged bottom chords were selected at the locations that were associated with relatively large tensile stress in the preliminary FEM analysis and thus considered vulnerable to fatigue damage.

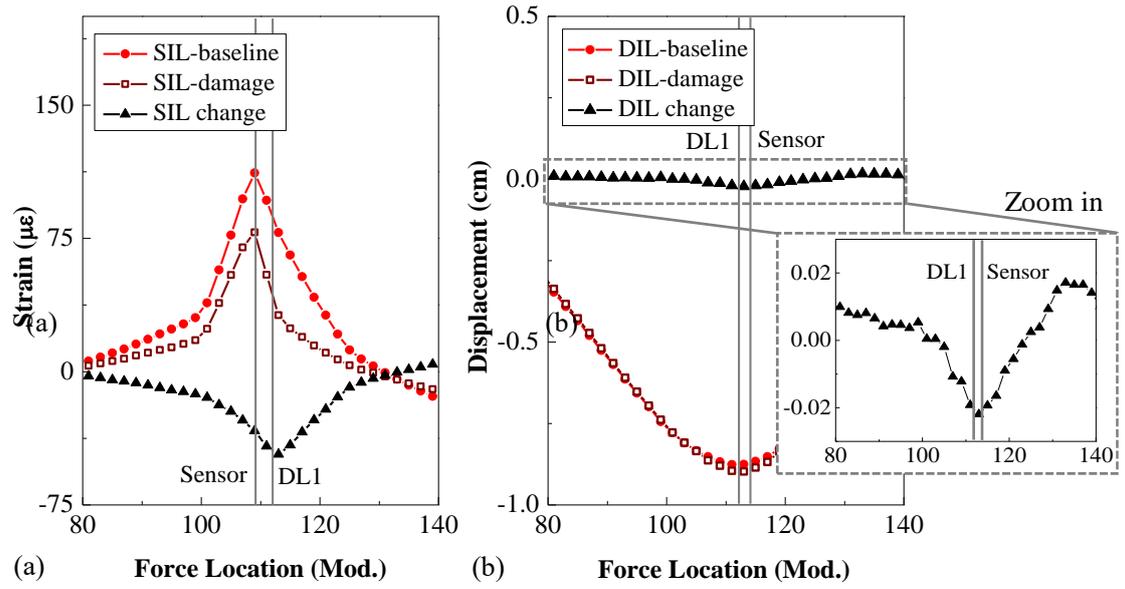
Fig. 8 ILs before and after single damage: (a) SIL of bottom chord: Mod. 109; (b) DIL of bridge deck: Mod. 114

Fig. 8 shows the representative results of the ILs before and after damage, wherein the SIL was measured from the bottom chord of Mod. 109, and the DIL was measured from the bridge deck of Mod. 114. The two vertical lines denote the sensor and damage locations. Although the SIL and DIL curves showed peaks at the sensor location, both the SIL and DIL change curves exhibited obvious peak values corresponding to the damage locations. Both the SIL and DIL change curves were almost symmetric with respect to the damage location. In this study, the change ratio of the IL is defined as the ratio between the peak-to-peak amplitude of IL change and the corresponding IL. The SIL and DIL change ratios were approximately 40% and 3.4%, respectively, demonstrating that SIL is more sensitive to local damage than DIL. The slight change ratio of DIL (i.e., 3.4%) indicated that a single structural truss component loss in such a complex long-span bridge has a limited effect on the overall structural performance, highlighting the difficulties in damage detection in complex long-span bridges using global indices directly. Consequently, only SIL results were used for damage localization in the

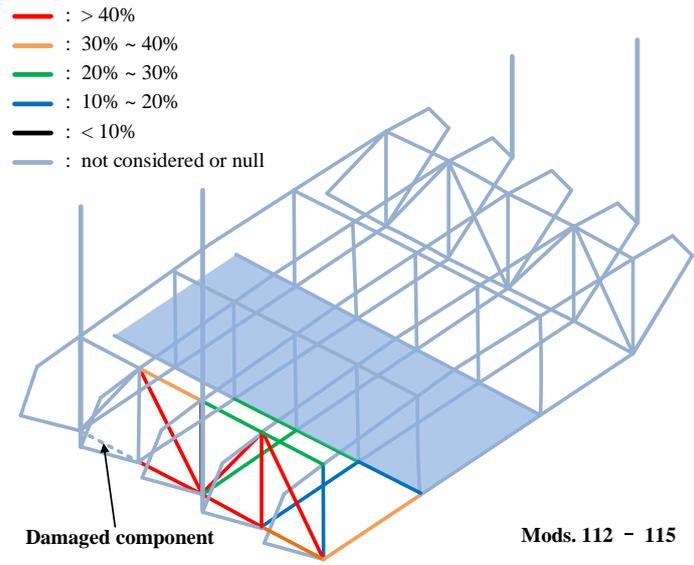
Fig. 9 SIL change ratios for different bridge components near the damage

Fig. 9 shows the SIL change ratio of different bridge components near the damaged bottom chord, which is shown by a dashed line. The lines with different lightness (or colors) were used to represent different change levels of SILs, namely, <10%, 10%–20%, 20%–30%, 30%–40%, and >40%. In particular, Fig. 10 presents the IL change of different bridge components of Mod. 114. An apparent peak indicating the damage location could be observed at all the concerned bridge components, despite the disturbance caused by the measurement noise. The SIL change of the bottom beam exhibited another sharp peak due to the sensing problem when the mass acted near the strain gauge. In descending order of the damage-induced strain change amplitude, the top three components were the bottom chord, railway beam, and top chord; these components exhibited dozens of microstrains change. As shown in Figs. 9 and 10, the bottom chord damage was relatively easy to be detected by the bottom chord and railway beam by considering the IL change amplitude and change ratio jointly.

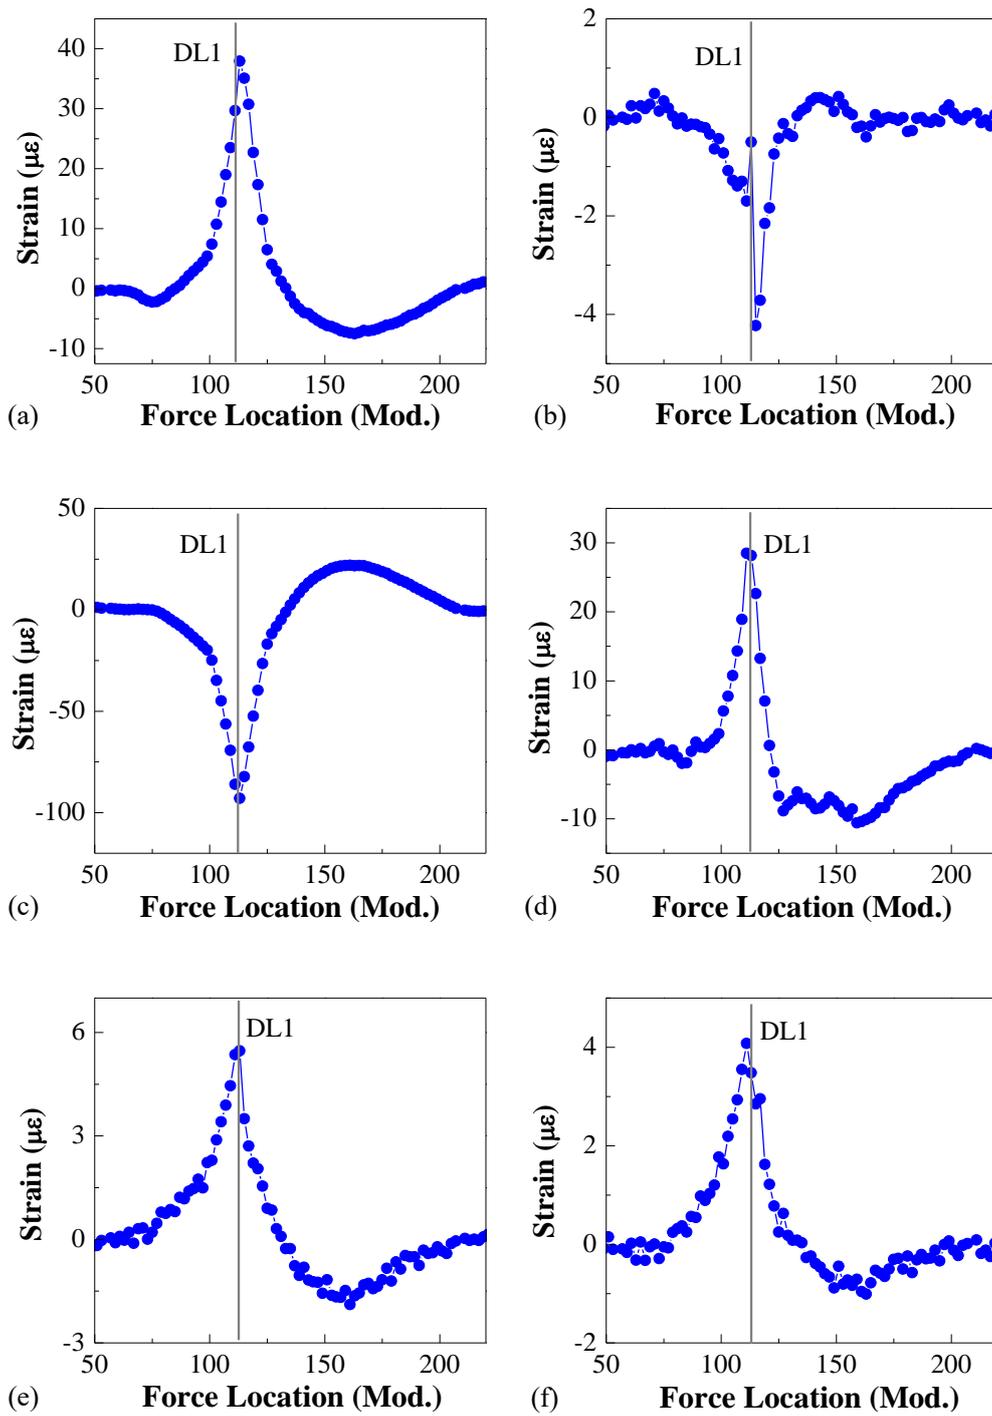
Fig. 10 SIL change of different bridge components: Mod. 114: (a) Railway beam; (b) Bottom beam; (c) Bottom chord; (d) Top chord; (e) Vertical post; (f) Diagonal chord

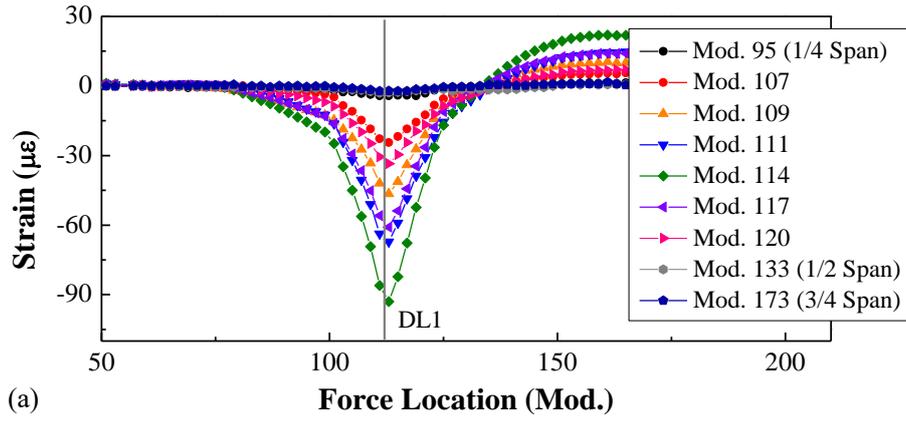
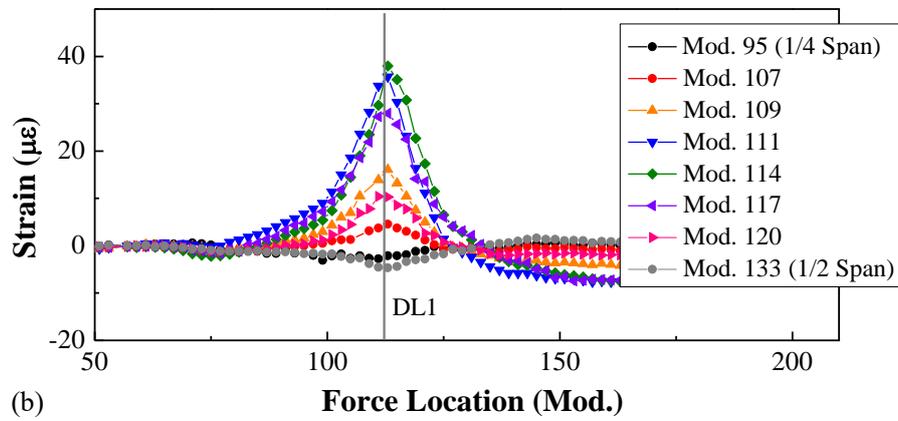
Fig. 11 SIL change of bottom chord and railway beam: (a) Bottom chord; (b) Railway beam

In addition, the SIL changes extracted from different railway beams and bottom chords were investigated, as shown in Fig. 11. The corresponding change ratio is presented in Fig. 12. The SIL change of the railway beam and bottom chord generally decreased with the increasing distance between the sensors and damage location. The SIL change ratio of the bottom chord was generally larger than that of the railway beam, given the same distance. For the bottom chords and railway beams, the SILs of Mods. 107 and 120 could still identify the damage at Mod. 112 accurately, whereas those SILs of Mods. 95 and 133 could not. This finding demonstrated that the detectable range of SIL was approximately 10 modules ( $\approx 0.6$  m), corresponding to approximately 4% of the whole length of the TMB model. Therefore, installing strain gauges on the longitudinal horizontal components every 10 modules could guarantee satisfactory detection performance in the entire bridge model.

identified visually in each SIL result. The peak locations were different: the SIL result extracted from Mod. 95 located the damage at Mod. 100, whereas that from Mod 107 located the damage at Mod. 112. Notably, according to Fig. 11, the detectable range of SIL in the single-damage case was approximately 10 modules. However, the SIL change of Mod. 107 cannot locate the second damage at Mod. 100 in this double-damage case. The reason is that the SIL of Mod. 107 was more sensitive to the damage in Mod. 112 due to the closer distance, whereas the corresponding SIL change of Mod. 107 induced by the Mod. 100 damage was much smaller and cannot be clearly identified. Note that the SIL change ratio of Mod. 107 was approximately 26% in the single-damage case (as shown in Fig. 12), whereas it only slightly increased to 28.5% because of the introduced second damage. These results implied the limited detectable range of the SILs again. Multiple SIL information will be required for multidamage detection in long-span bridges.

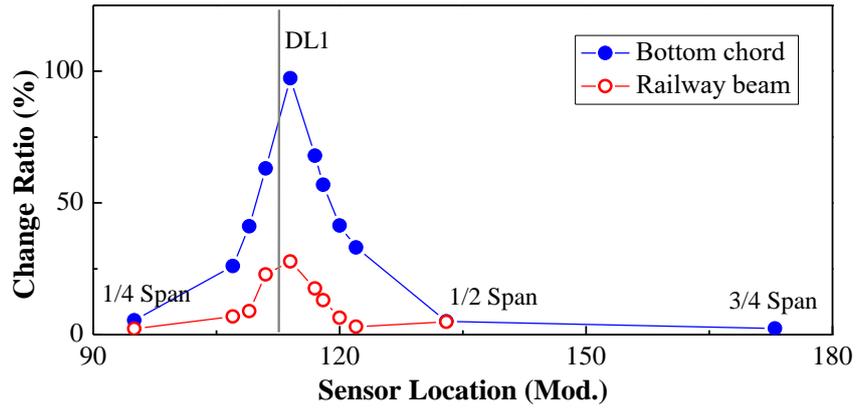
Fig. 12 Change ratios of SILs with sensor locations

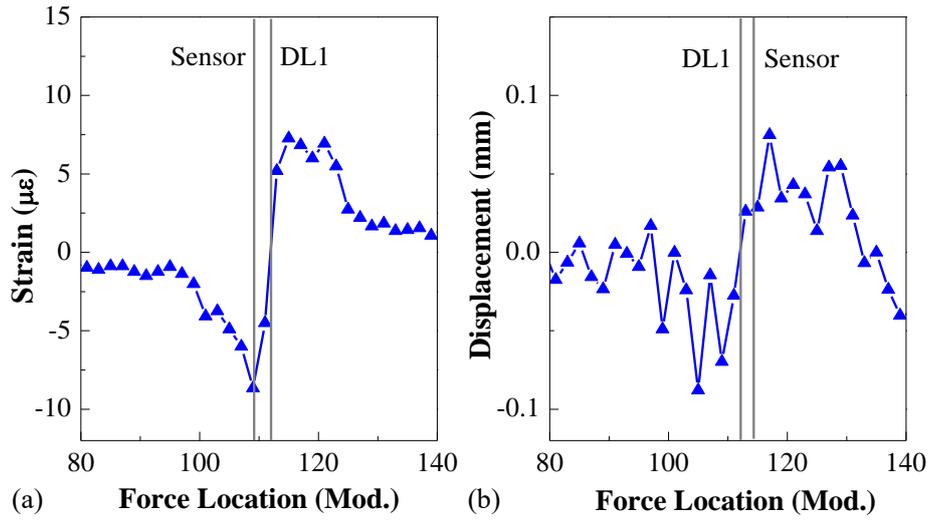
Fig. 13 Damage localization results using the first-order finite difference of IL change: (a) SIL of bottom chord: Mod. 109; (b) DIL of bridge deck: Mod. 114

Fig. 13 shows the damage detection results using the mentioned first-order finite difference of the IL change by taking the SIL of the bottom chord of Mod. 109 and the DIL of Mod. 114 as examples. Although the calculation of finite difference amplified the noise effect, the damage location could still be located by identifying the sudden change of either SIL or DIL. This result demonstrated the effectiveness of the first-order finite difference-based indices for damage detection in long-span bridges and confirmed the findings of the previous numerical study using a full-scale FEM (Chen et al. 2015).

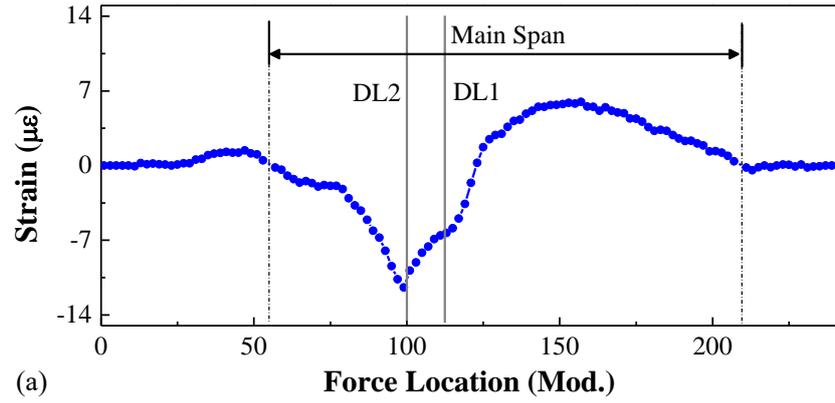
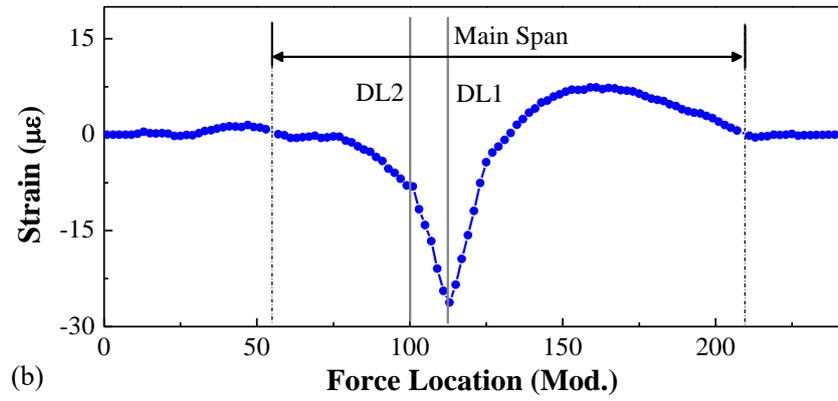
Fig. 14 Damage localization results for double-damage case: (a) Mod. 95; (b) Mod. 107

As mentioned, the second damage was done by cutting off the bottom chord of Mod. 100. Fig. 14 shows the corresponding detection results using the SIL change of the bottom chords in Mods. 95 and 107. Only one apparent peak corresponding to the damage location could be

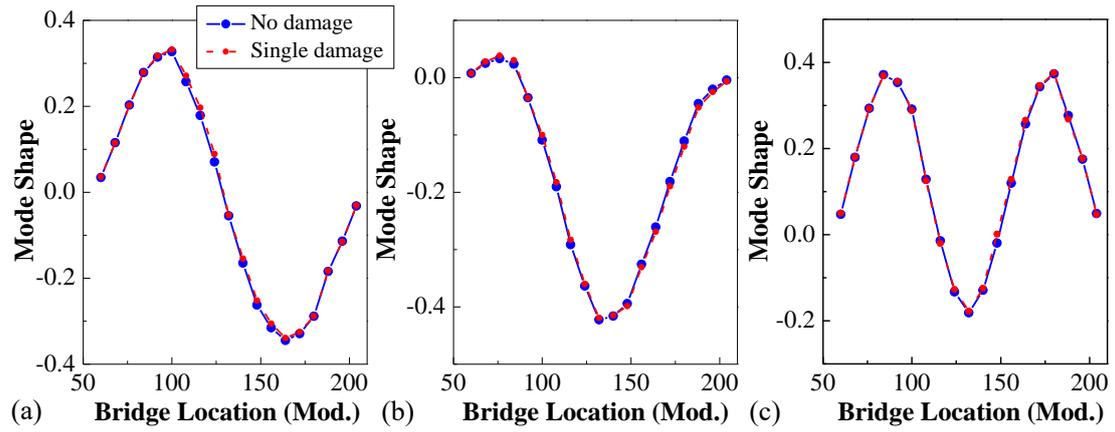
Fig. 15 Identified mode shapes before and after single-damage simulation: (a) First order; (b) Second order; (c) Third order

Fig. 15 depicts the extracted first three mode shape information of the main span of the bridge model before and after the single-damage simulation. The difference was quite small; the damage occurrence could not be identified based on this difference. The first vertical mode shape was almost antisymmetric, whereas the second vertical mode was symmetric with a half-wave, regardless of whether the damage occurred or not. The modal assurance criterion (MAC) (Pastor et al. 2012) was applied to detect damage occurrence. Table 4 lists the specific vertical modal frequencies information and the calculated MAC values. The maximum natural frequency change was merely 2.6%, and the MAC values were above 0.99. The change ratios of the modal information in Table 4 were much smaller than that in Fig. 9 (mostly > 10%). The limited number of sensors led to the low spatial resolution of the mode shapes. As a result, the modal curvatures could not be accurately computed, and the corresponding detection performance was poor. The experimental results indicated that compared with the SIL-based indices, the modal parameter change might not be suitable for the direct detection of the local damages in long-span bridges. It was also noted that the identified natural frequencies were slightly different from those reported by Xu et al. (2012) due to the recent change in the TMB
